2020 Quarterly Site Inspections

Clean Harbors Lambton Facility
4090 Telfer Road, Corunna, Ontario

Clean Harbors Canada, Inc.

Subject: 2020 First Quarter Site Inspection

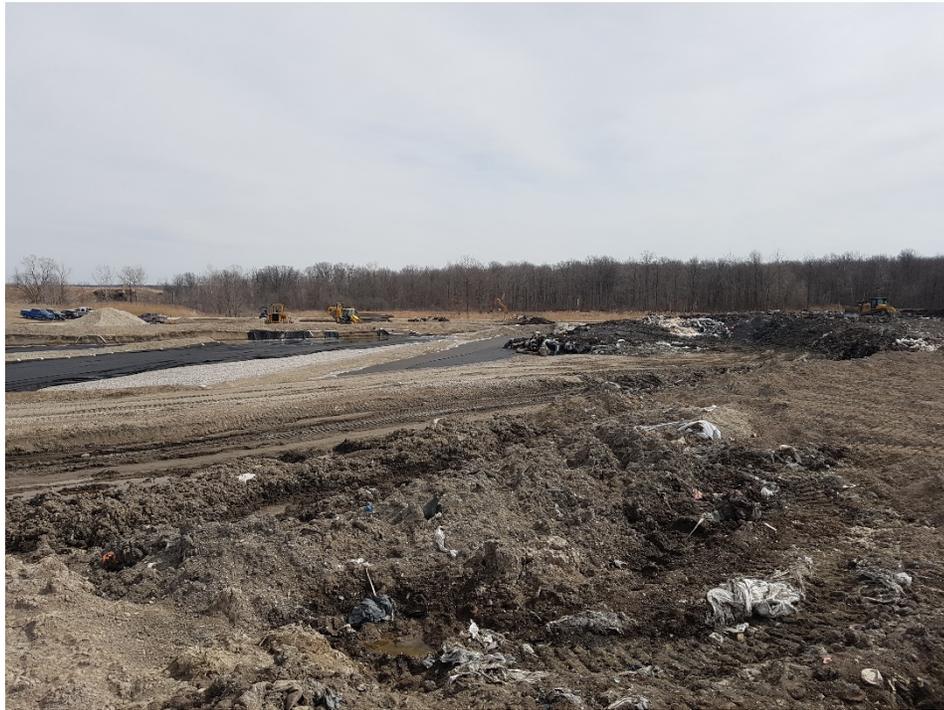
- The active waste tipping face is located in the south western portion of Cell 19-2. Waste placement is generally occurring from south to north, as shown in Photo 1. At the time of the inspection the fill operations were located along the southeastern limit of waste disposal.
- The eastern portion of Cell 19-2 construction has been completed, as shown in Photos 2 through 5.
- Waste Transport Route: Site waste haulers are directed around the east side of the Process Area and enter Cell 19-2 from the north side, located centrally within the active landfilling area, on a dedicated haul road from the Waste Receiving Area.

Photo 1 - Active landfilling cell, Cell 19-2

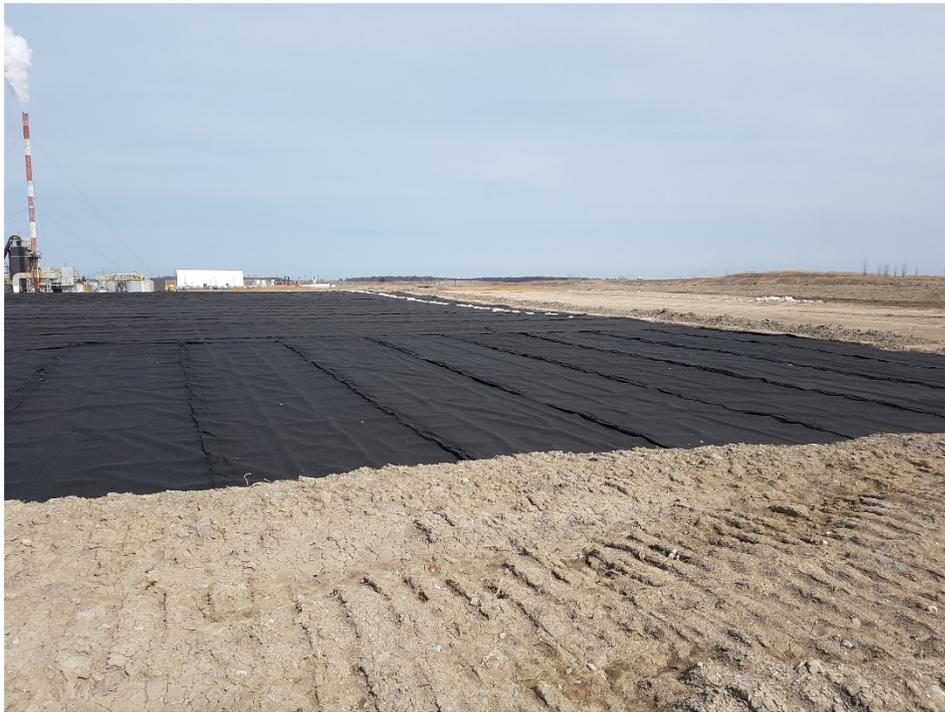
- Final cover installation has continued in Cell 19-1, with the protective soil cover being placed west to east along the south portion of 19-1, as shown in photo 7.

Photo 7 - Protective soil cover on Cell 19-1 final cover

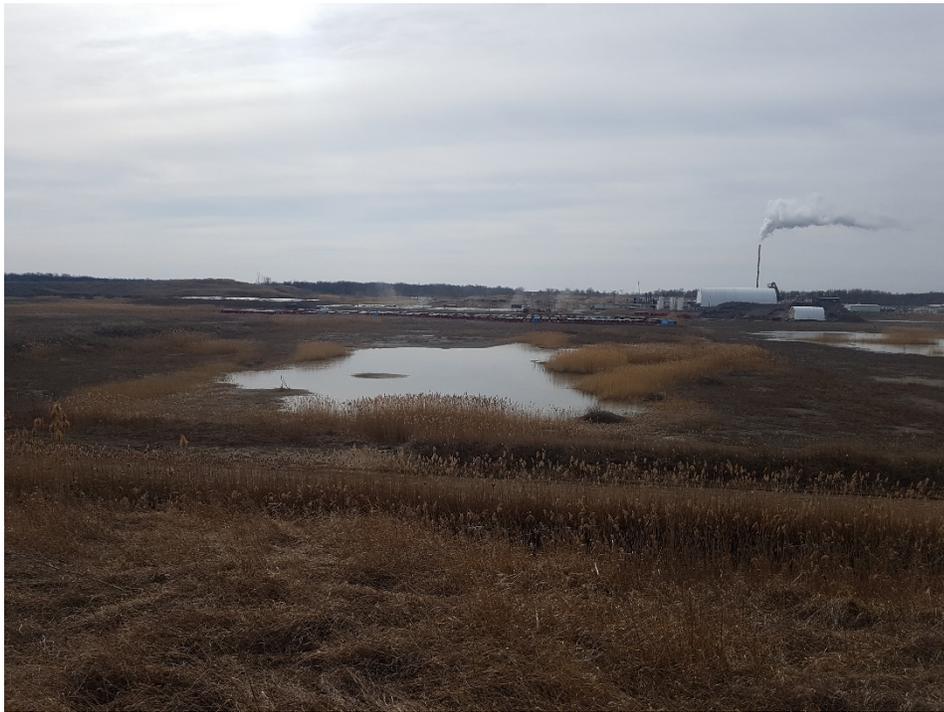
- A large area of standing water was noted in the northwest portion of proposed Cell 21-3 (i.e., located centrally in the northern portion of the Site), as shown in Photo 9. The two drainage paths were under water during the Inspection, with no observed flow.

Photo 9 – Standing water in northern, central portion of site

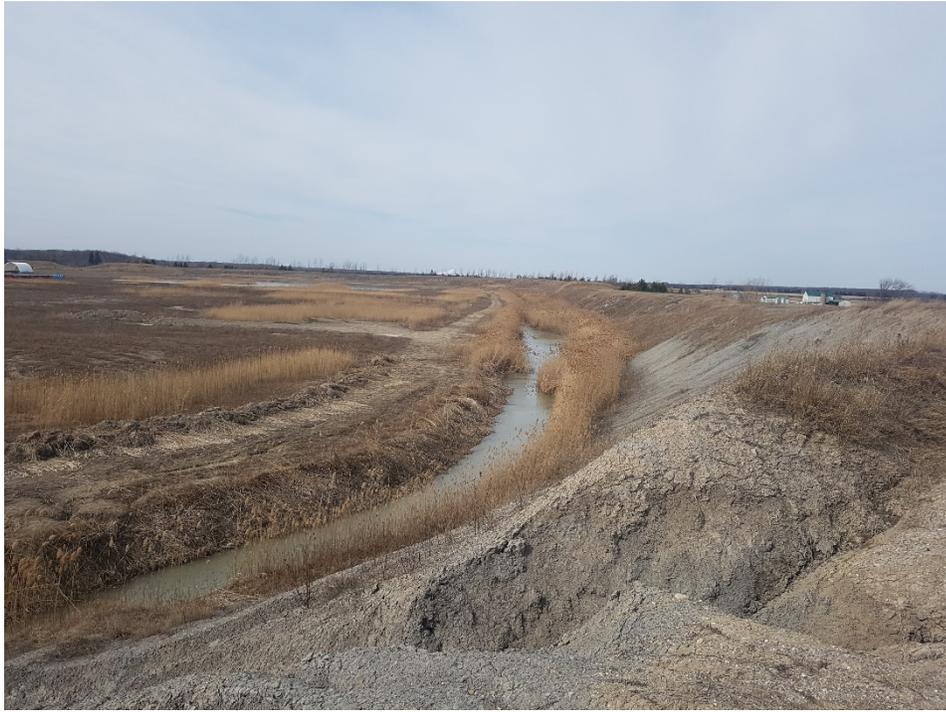
- Vegetation and sedimentation was previously removed from the northeastern ditch. However, standing water was observed in the perimeter ditch in the northeast corner of the Site (i.e., at the location of the former perimeter screening berm access road) with no notable flow, as shown in Photo 11 and Figure 1.

Photo 11 - North ditch, standing water

Maintenance of the perimeter ditches is required to remove areas where sediment has accumulated and is restricting flow of water. Maintenance of the perimeter ditches is a key component to minimize standing water on the interim cover and promote transfer of water to surface water ponds. It is recommended that perimeter ditch maintenance be undertaken to remove blockages as noted. The maintenance work should minimize the potential for flooding during storm events.

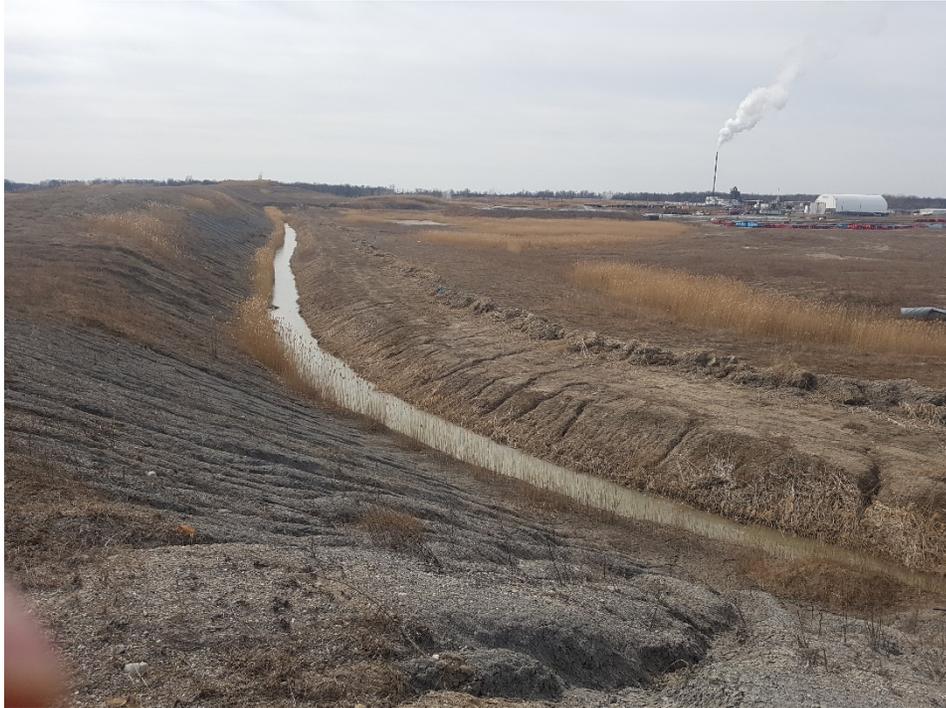
- Significant erosion was identified in the southeast corner of the OLA, resulting in sedimentation of the perimeter ditch and limited water flow, as shown in Photo 12 and Figure 1. This portion of ditch was wet, with standing water noted and dense wetland vegetation. Standing water was observed in the internal swale and low-lying area to the north, as shown in Photo 13 and Figure 1.

Photo 12 - Original Landfill Area, east ditch, standing water

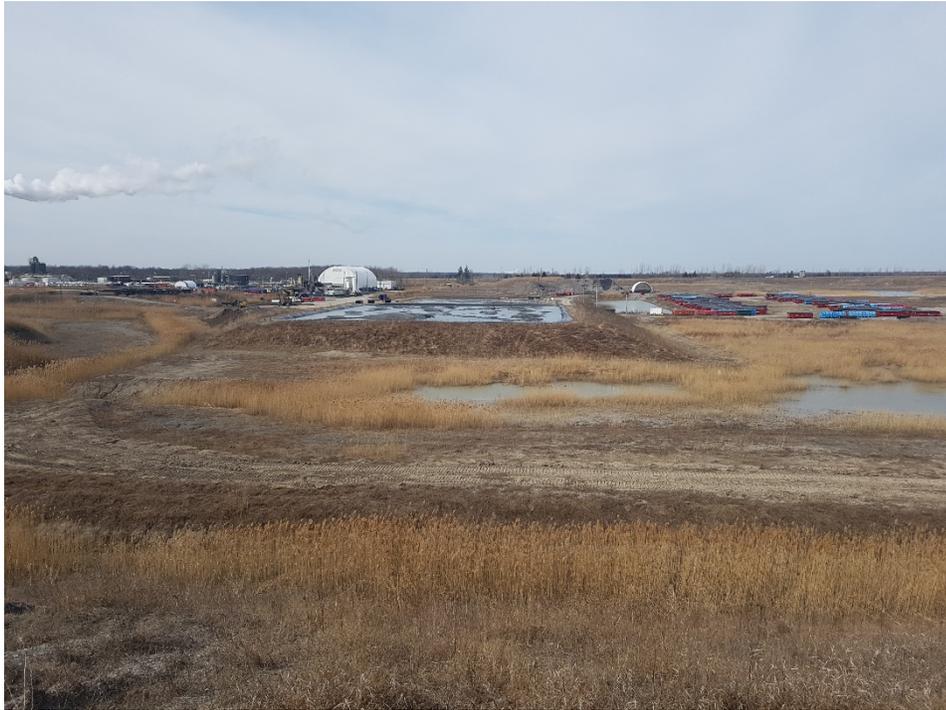
Photo 13 – Standing water in southeast corner of Original Landfill Area

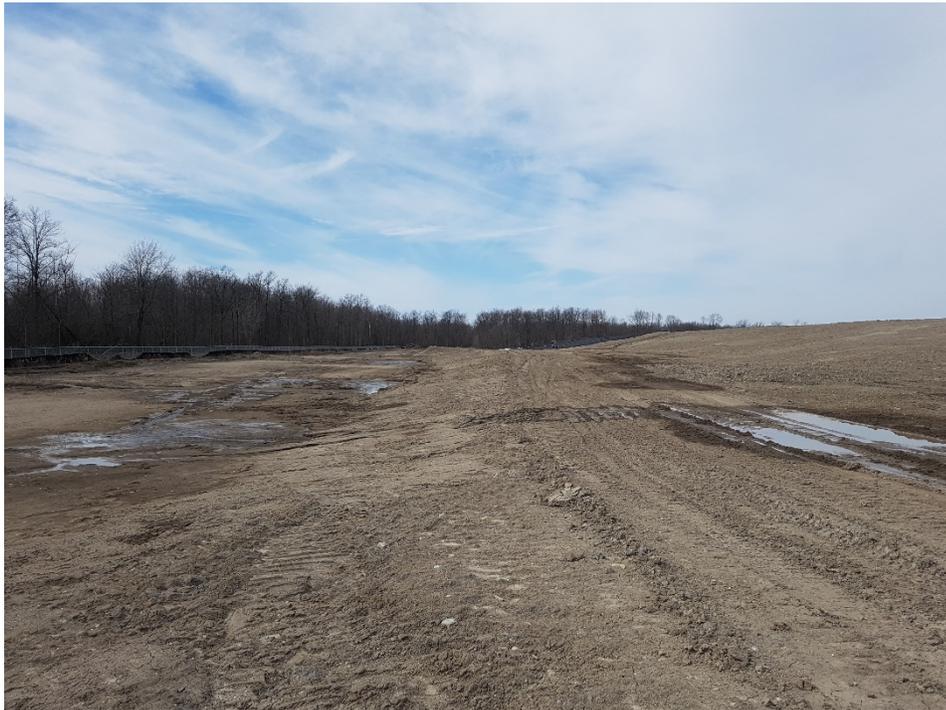
- Damp conditions were observed in the east perimeter ditch between the OLA and the East Surface Water Pond.
- The area of the completed south ditch remediation is generally dry with minimal standing water south of cell 19-1 and cell 19-2, as shown in Photo 14

Photo 14 – Standing water south of Cells 19-1 and 19-2

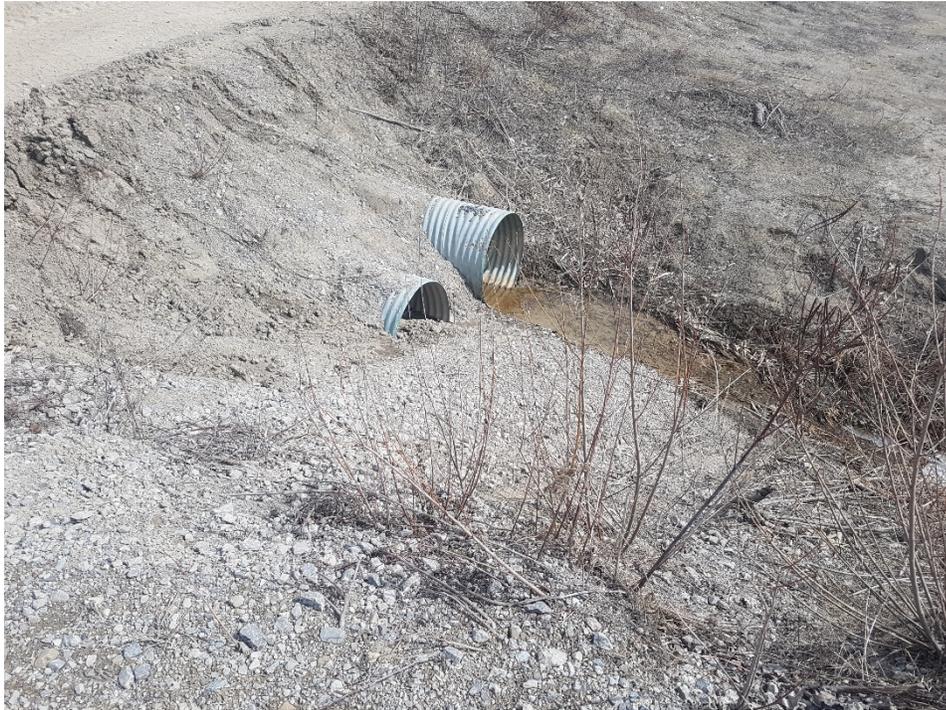
- One of two culverts running under the access ramp to the soil borrow area is partially buried, as shown in Photo 15 and Figure 1.

Photo 15 – Partially buried culvert at borrow area entrance

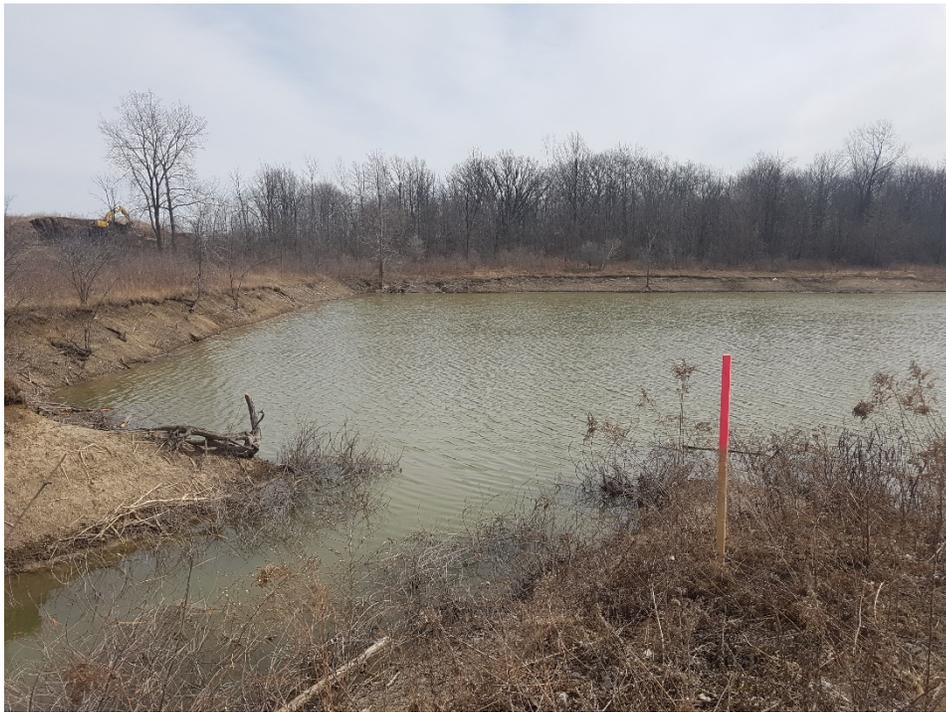
- Water levels within the East Surface Water Pond were moderate, below the baseline of vegetation.
- No flow was observed entering the East Surface Water Pond from the south.
- Stormwater from the inactive 19-2 sub-cells was being pumped into a ditch discharging into the west side of the East Surface Water Pond.
- The pump at the East Surface Water Pond was in operation at the time of Inspection. Water is pumped directly from the East Surface Water Pond to the West Surface Water Pond via piping.

Photo 16 – East Surface Water Pond

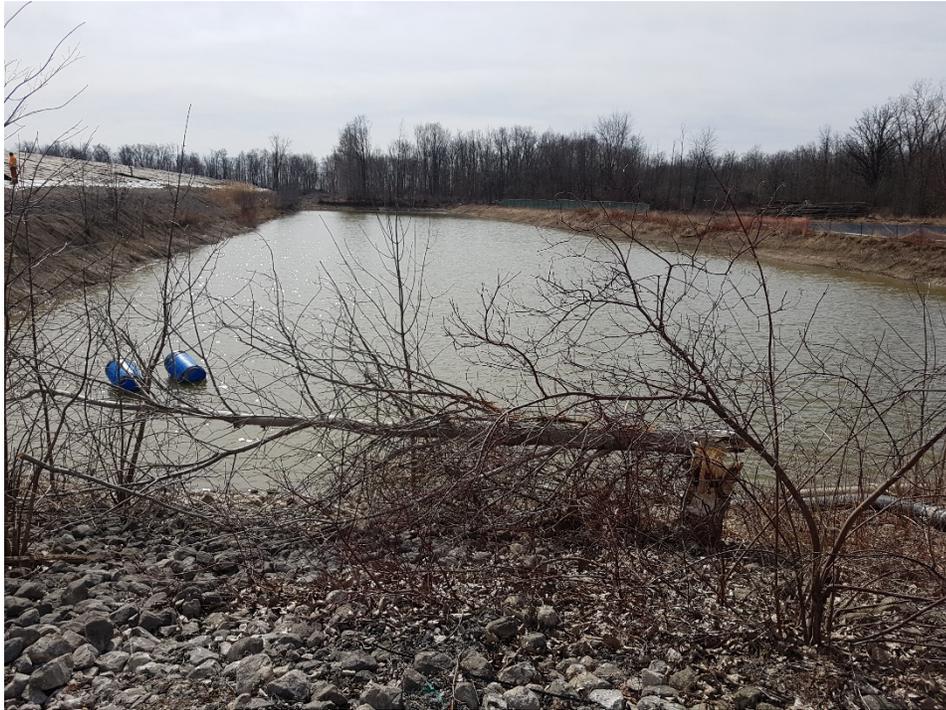
- Water levels within the West Surface Water Pond were low, below the baseline of vegetation.
- The pump at the West Surface Water Pond was in operation at the time of Inspection.

Photo 17 - West Surface Water Pond

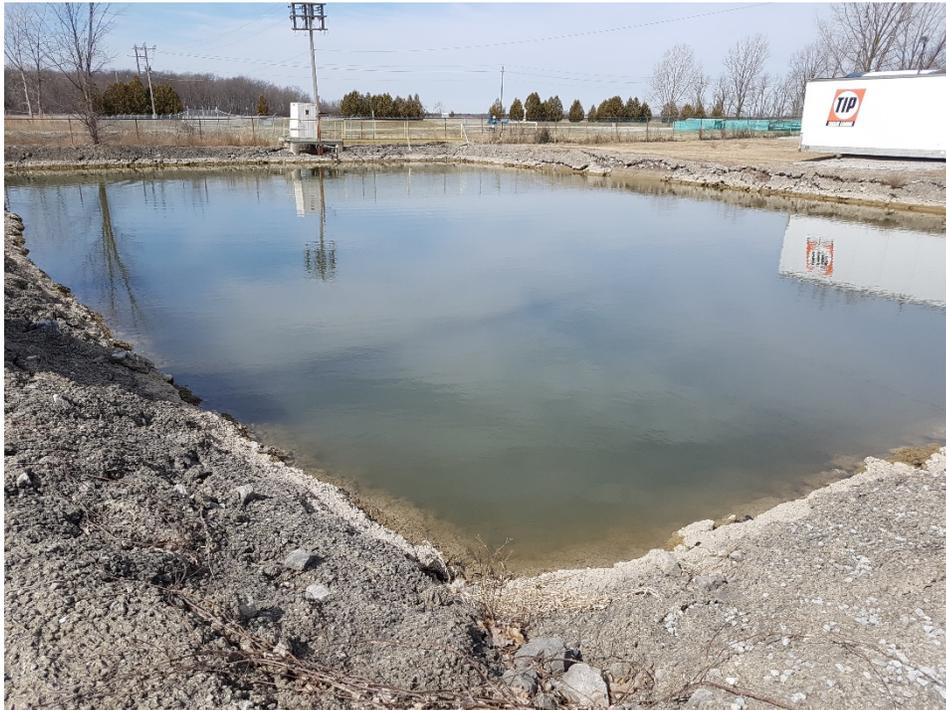
- Water levels within the Equalization Pond were moderate. Flow was not observed entering the Equalization Pond at the time of Inspection.
- Cracking and sloughing of the concrete side walls of the Equalization Pond was observed during the Inspection.
- No fish were observed within the Equalization Pond.

Photo 18 - Equalization Pond

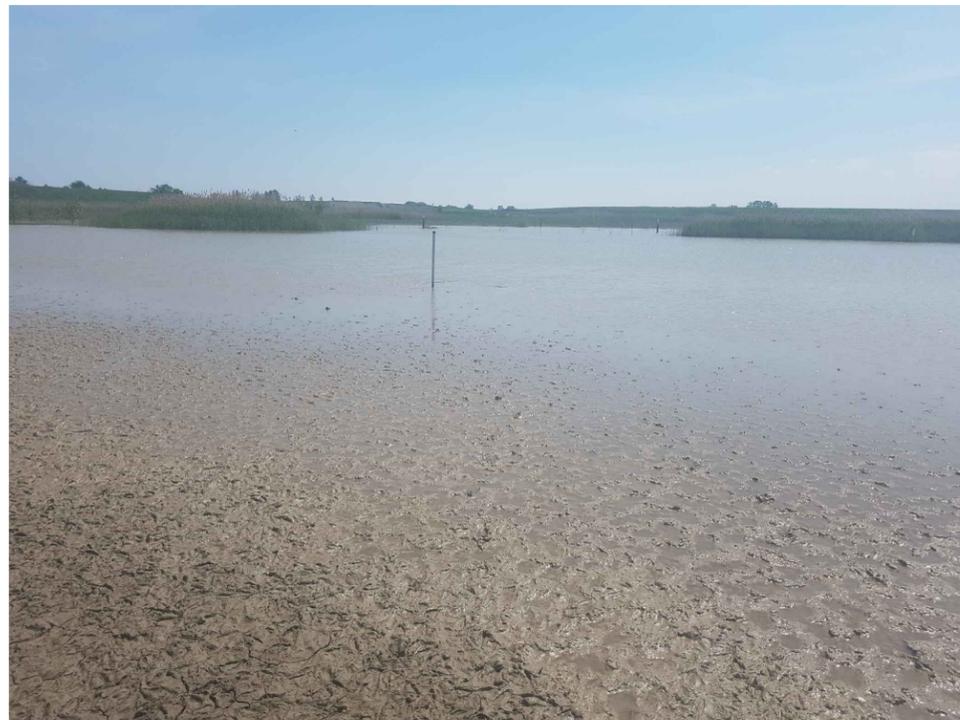
9 NORTH WEST AREA WITH PONDED WATER
Fig 4A

- Low/depressed areas in the north of the site to be assessed and the interim cover regraded to promote drainage. These areas are proposed to be addressed during 2020 as part of the capital works and the availability of excess soils.
- As active site works progress from south to north it is recommended that the perimeter berm is regraded, covered in topsoil and seeded to prevent future erosion in to the surface water system.
- Regular maintenance of the perimeter ditches is recommended until the perimeter berm erosion channels can be regraded, covered in topsoil and seeded. Maintenance of the perimeter ditches is a key component to minimizing standing water on the site. Maintenance includes removing silt, cutting back vegetation and removing blockages.

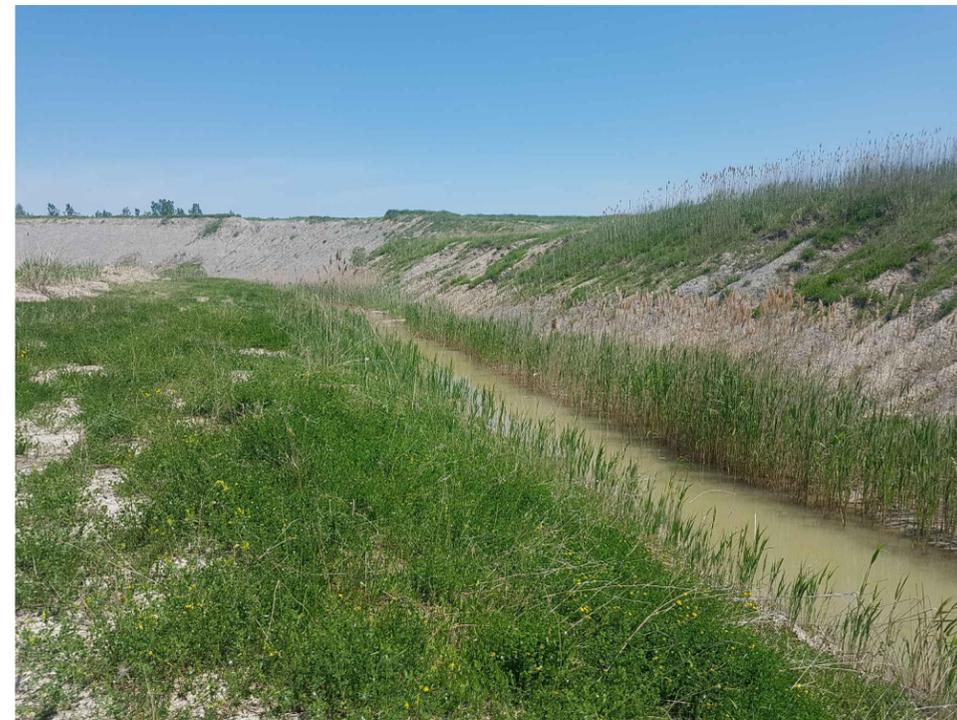
10 EROSION CHANNELS ALONG PERIMETER BERM AND STANDING WATER IN NORTH EAST DITCH
Fig 4A

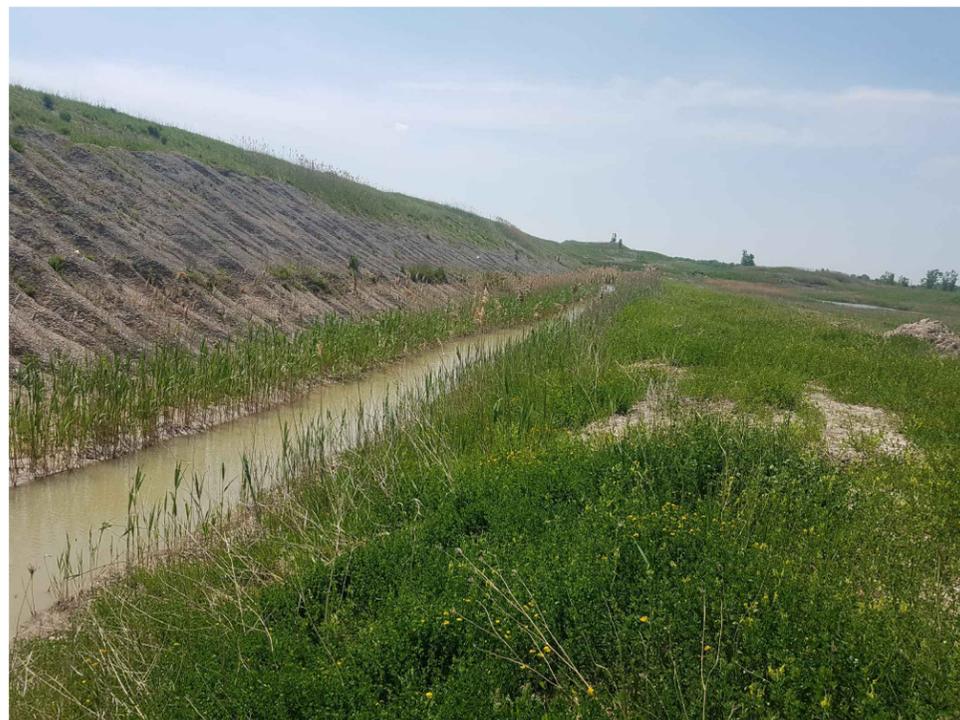
11 EROSION CHANNELS ALONG PERIMETER BERM AND STANDING WATER IN NORTH EAST DITCH
Fig 4A

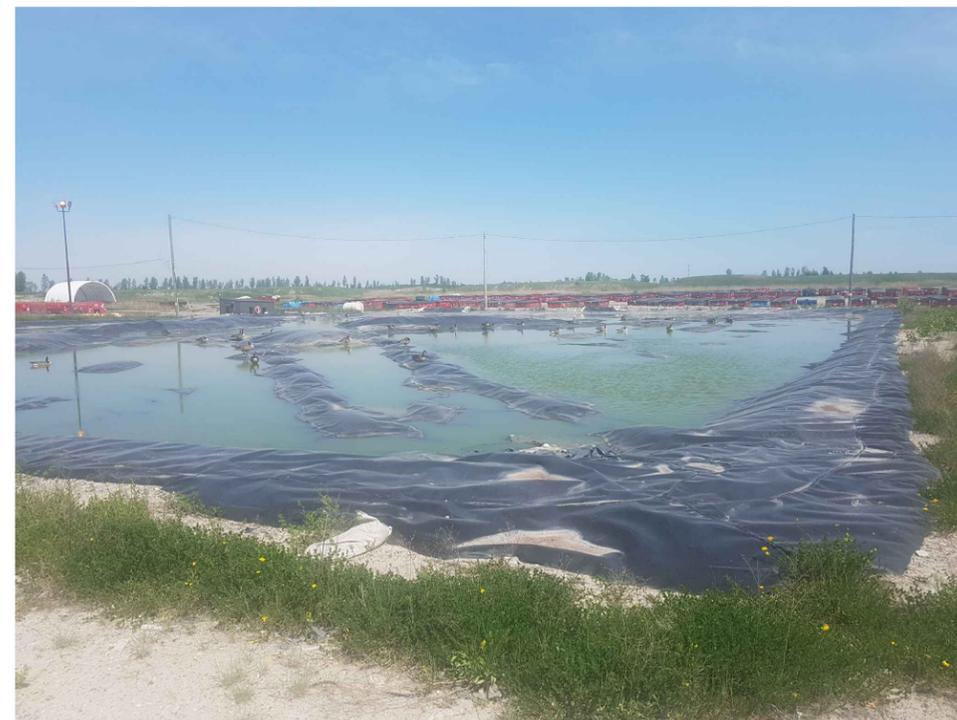
12 PONDED WATER ON LEACHATE POND COVERS
Fig 4A

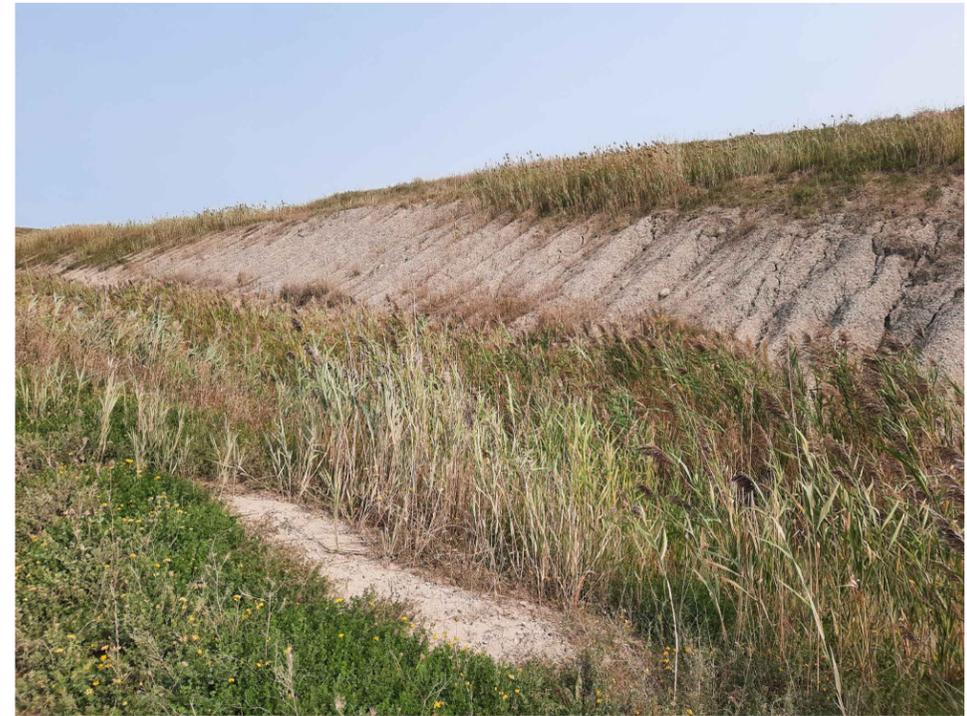
10 EROSION CHANNELS ALONG PERIMETER BERM
Fig 4A

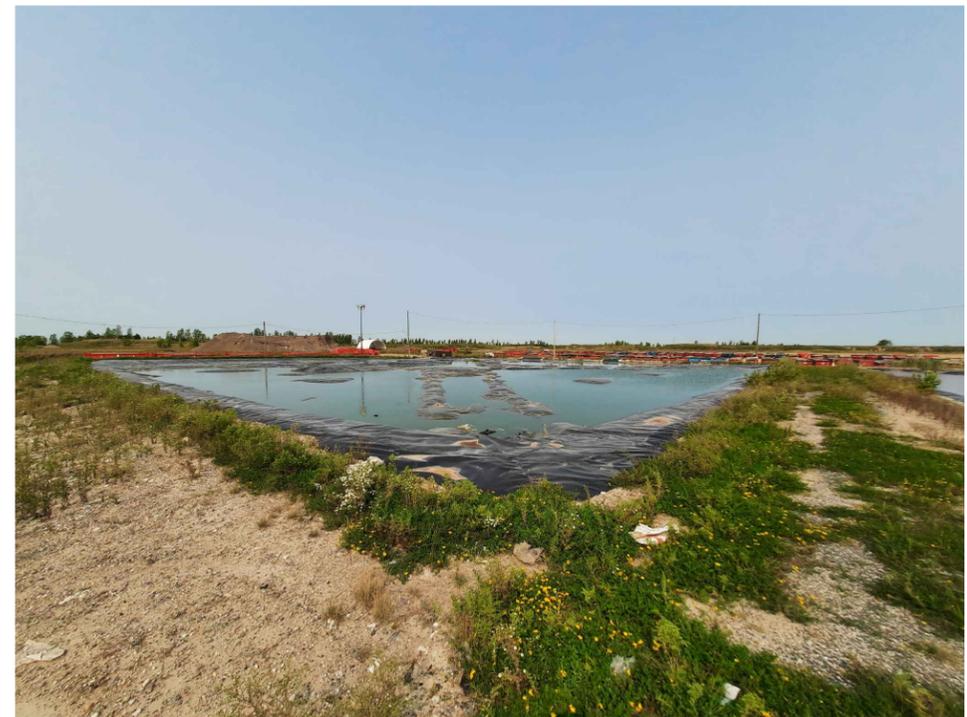
12 PONDED WATER ON LEACHATE POND COVERS
Fig 4A
