2020 Quarterly Site Inspections

Clean Harbors Lambton Facility
4090 Telfer Road, Corunna, Ontario

Clean Harbors Canada, Inc.

Subject: 2020 First Quarter Site Inspection

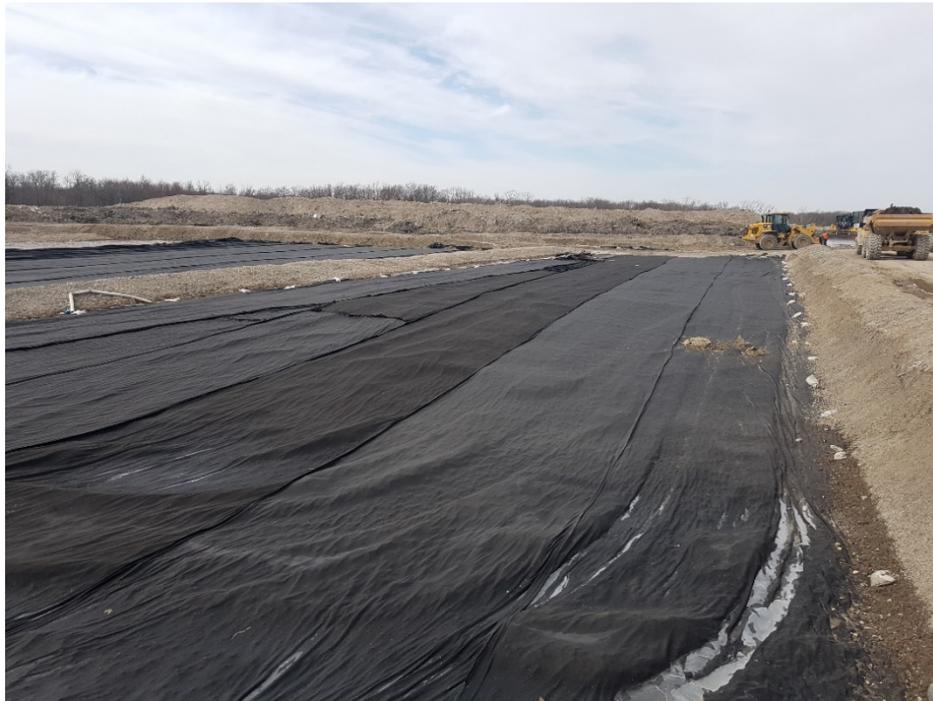
Photo 2 – Completed sub-cells, Cell 19-2

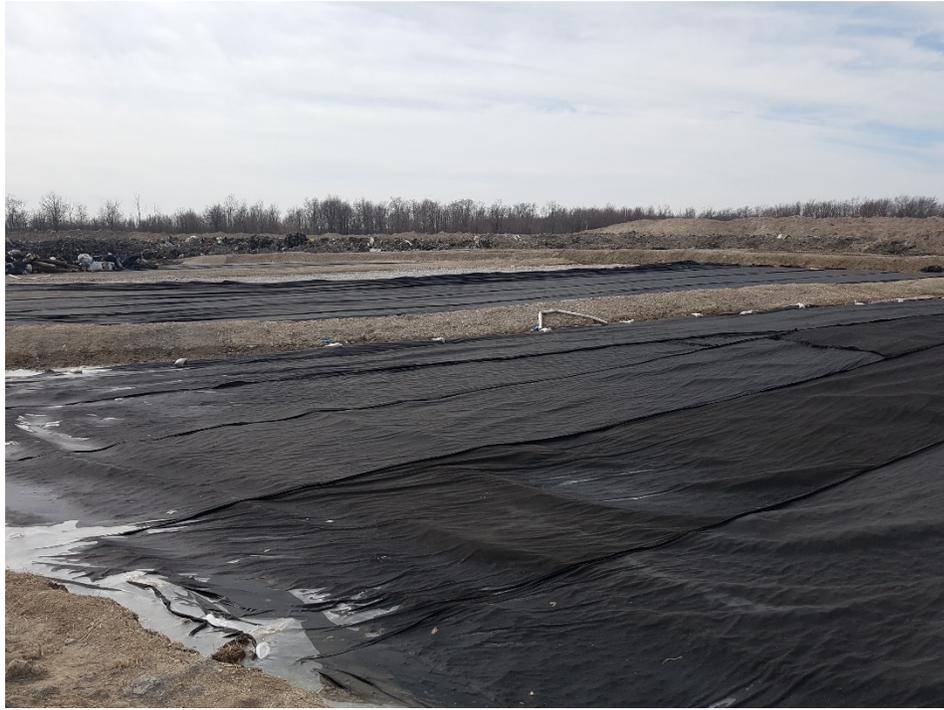
Photo 3 - Completed sub-cells, Cell 19-2

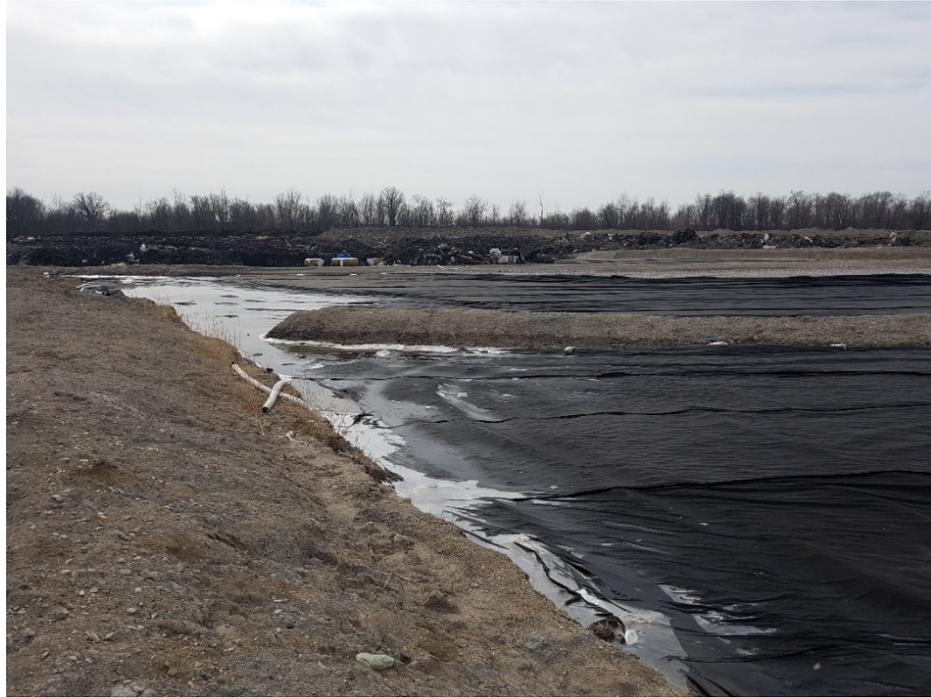
Photo 4 - Completed sub-cells, Cell 19-2

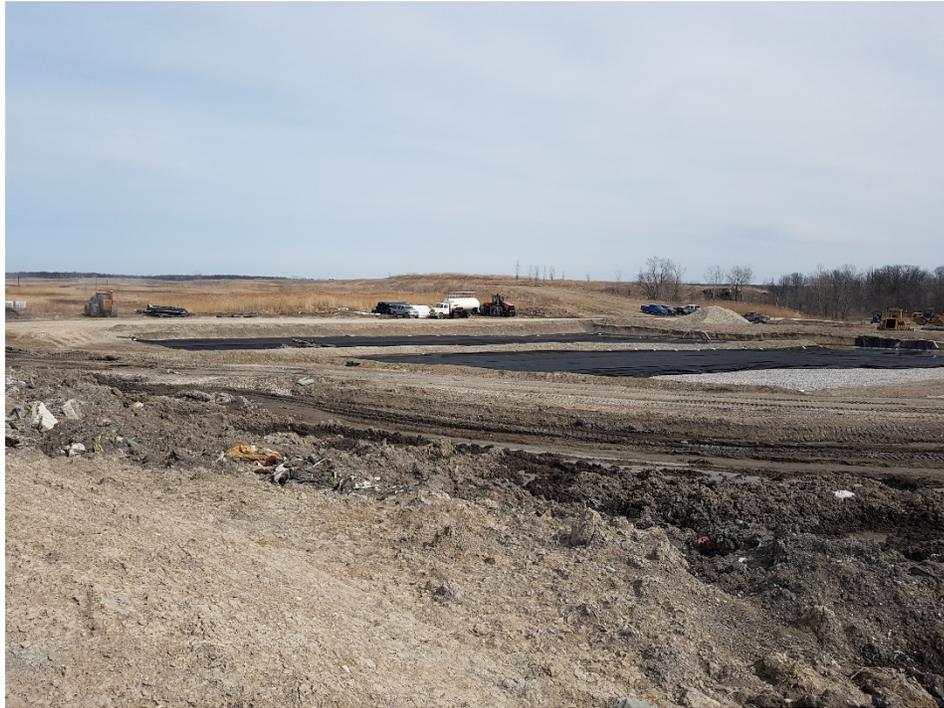
Photo 5 - Completed sub-cells, Cell 19-2

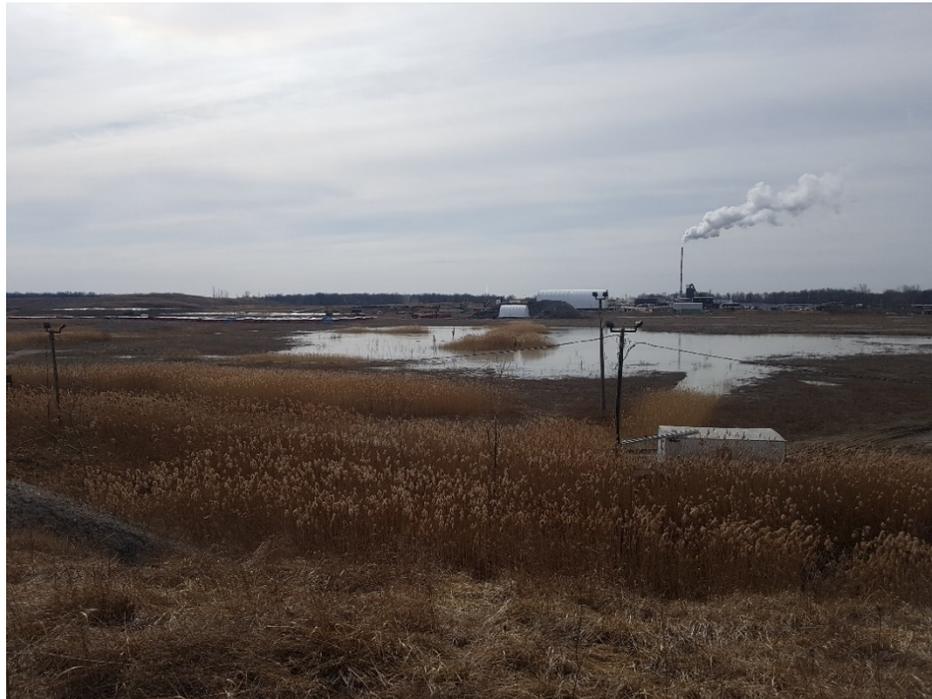
Photo 8 - Standing water in northwest corner of Site

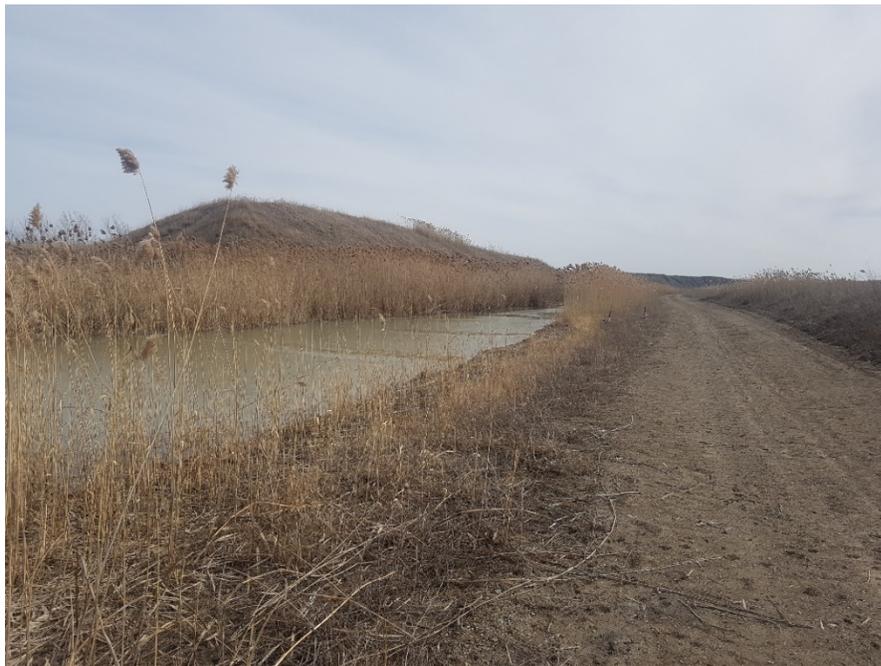
- Water levels continue to be high in the central portion of the north ditch, as shown in Photo 10. High water levels in the north ditch have the potential to prohibit surface drainage from the OLA during wetter periods.

Photo 10 - High water levels in central portion of north perimeter ditch

Maintenance of the perimeter ditches is required to remove areas where sediment has accumulated and is restricting flow of water. Maintenance of the perimeter ditches is a key component to minimize standing water on the interim cover and promote transfer of water to surface water ponds. It is recommended that perimeter ditch maintenance be undertaken to remove blockages as noted. The maintenance work should minimize the potential for flooding during storm events.

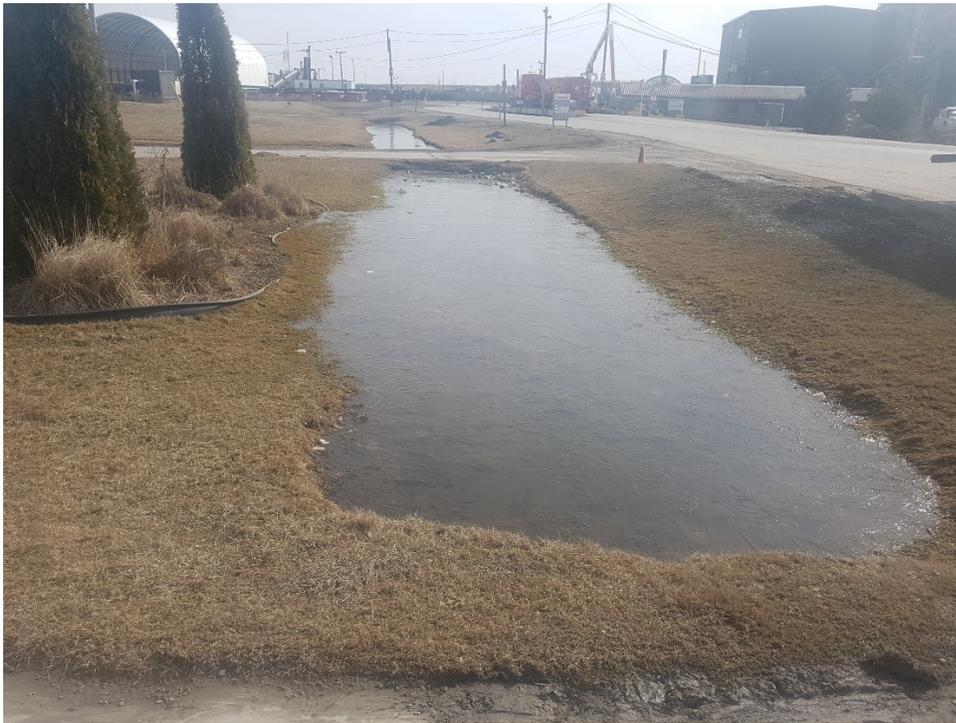
Photo 199 - North Process Water Pond inlet ditches

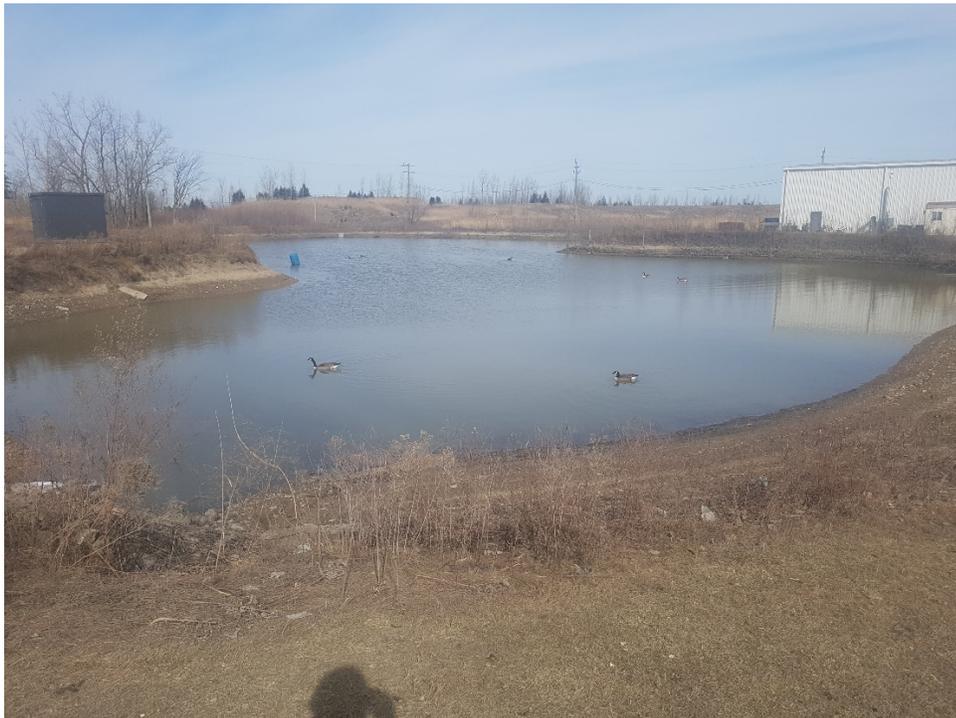
Photo 20 - North Process Water Pond

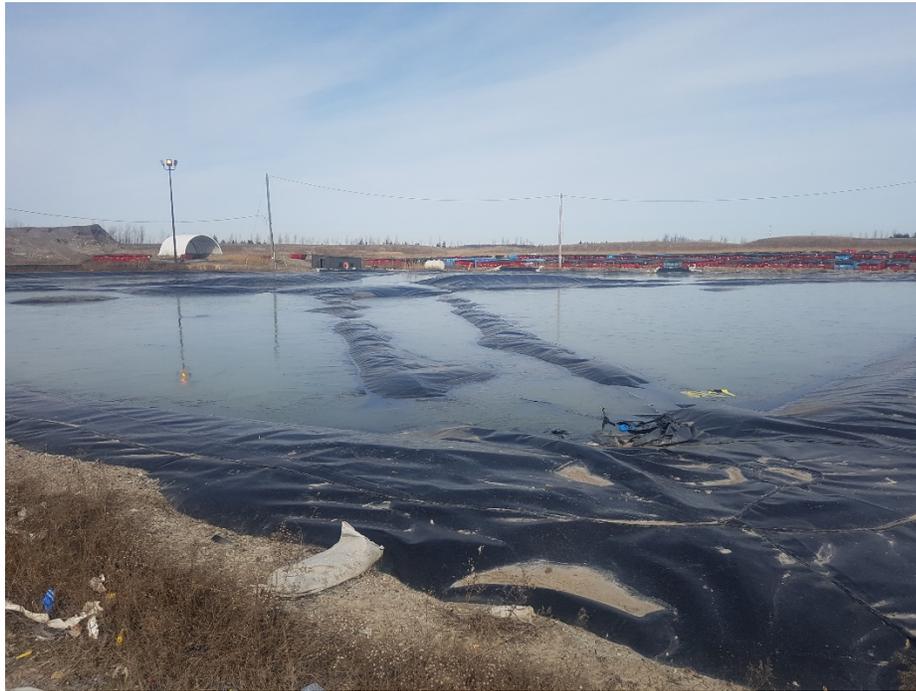
Photo 21 - South Leachate Reservoir

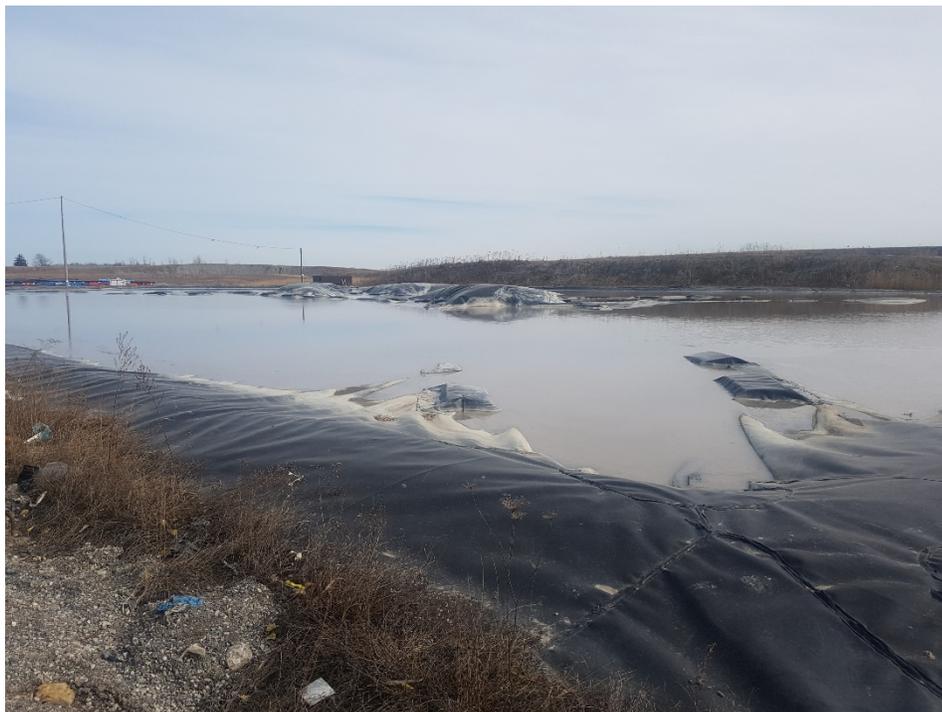
Photo 22 - East Leachate Reservoir

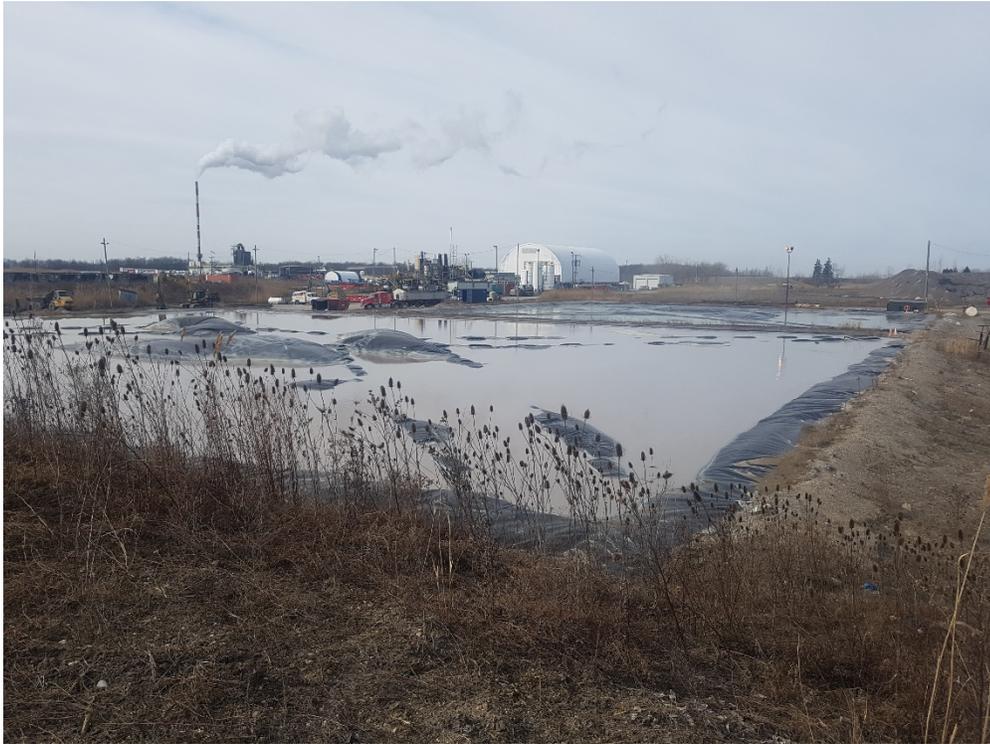
Photo 23 - New Leachate Reservoir

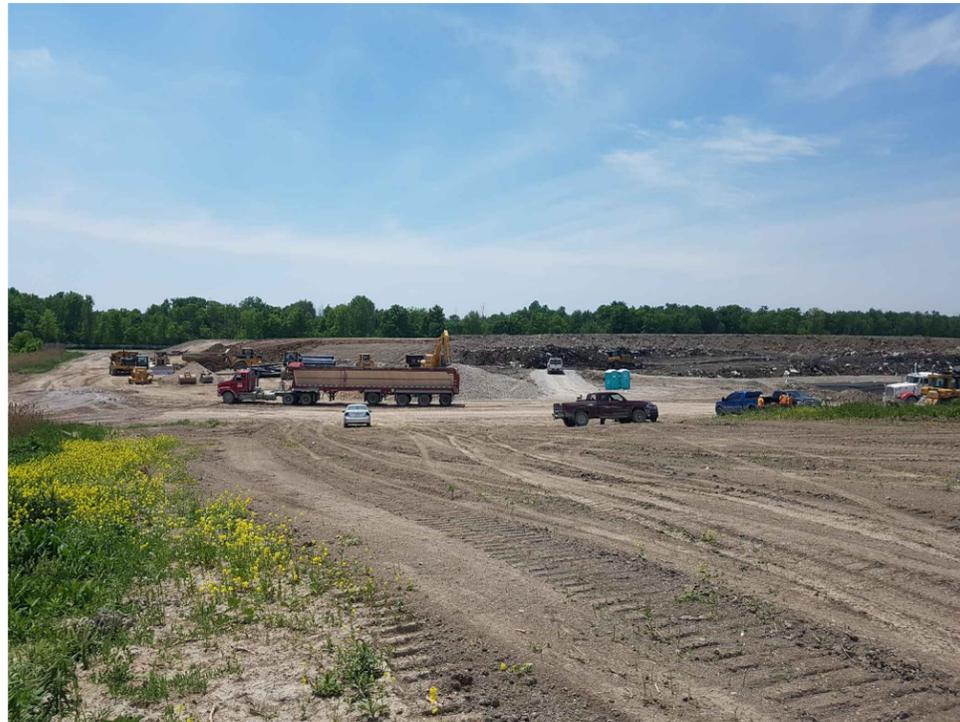
1 ACTIVE WASTE FACE (CELL 19-2F)
Fig 3A

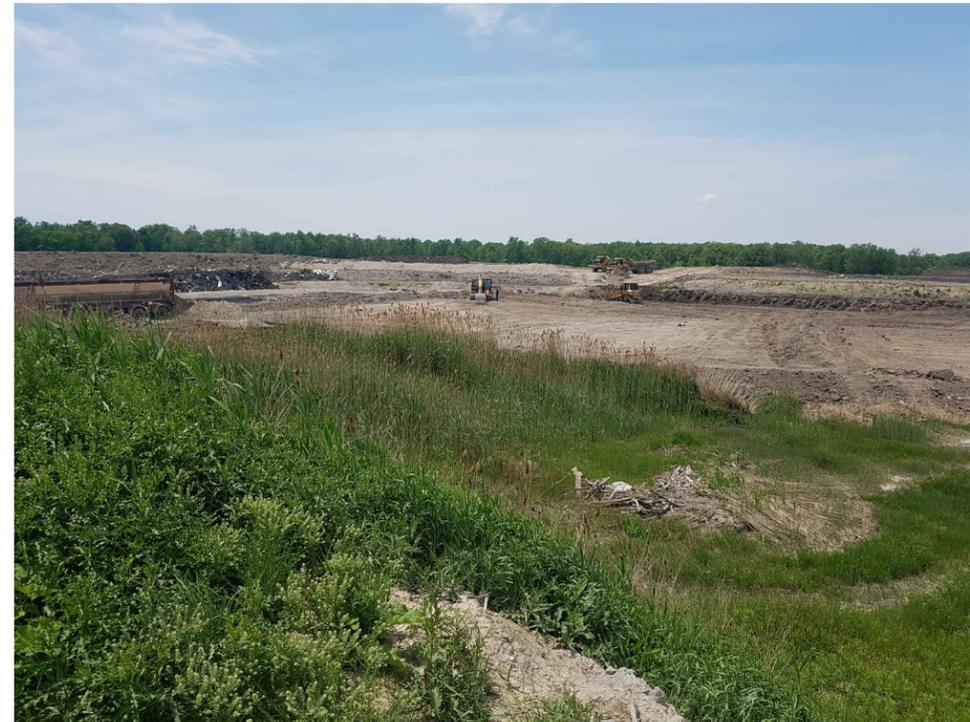
2 CELL 19-3B CONSTRUCTION
Fig 3A

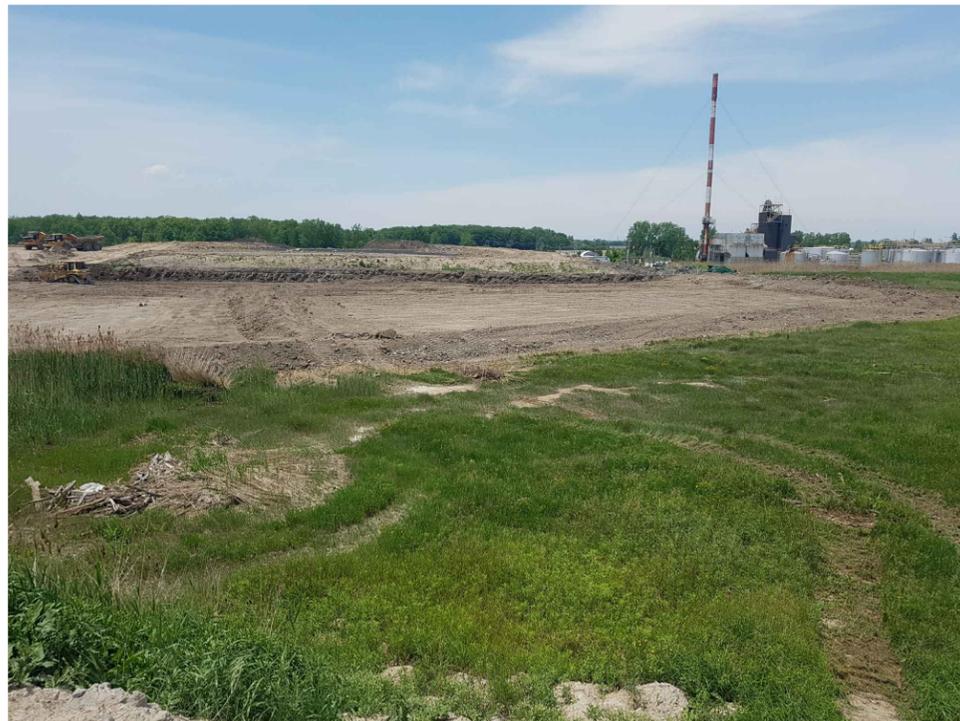
3 CELL 19-3B CONSTRUCTION
Fig 3A

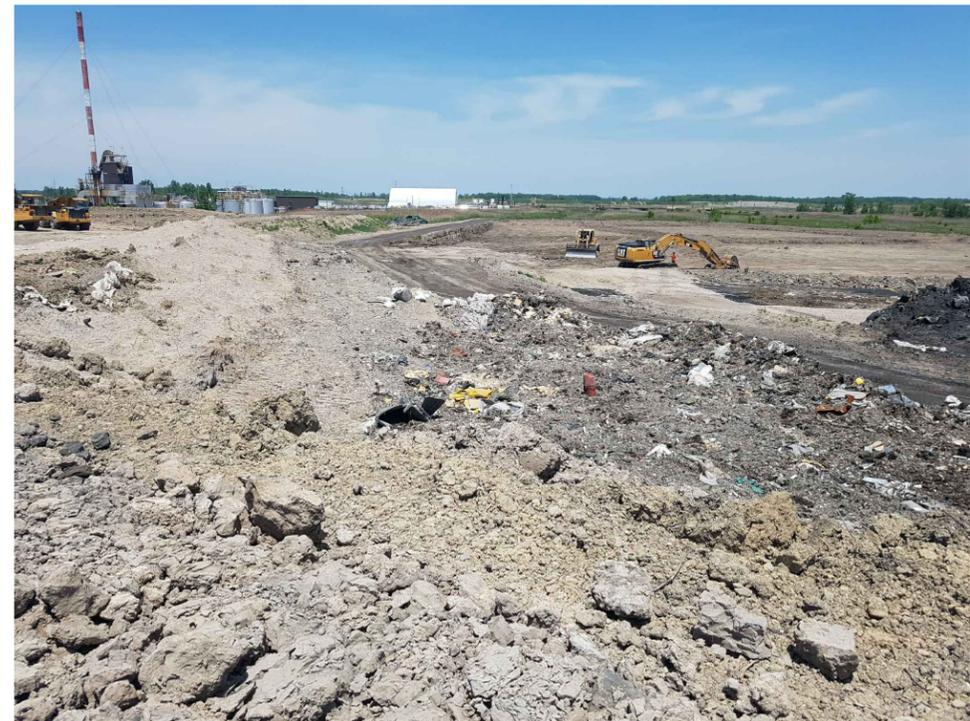
4 WASTE HAUL ROAD AND CELL 19-3F CONSTRUCTION
Fig 3A

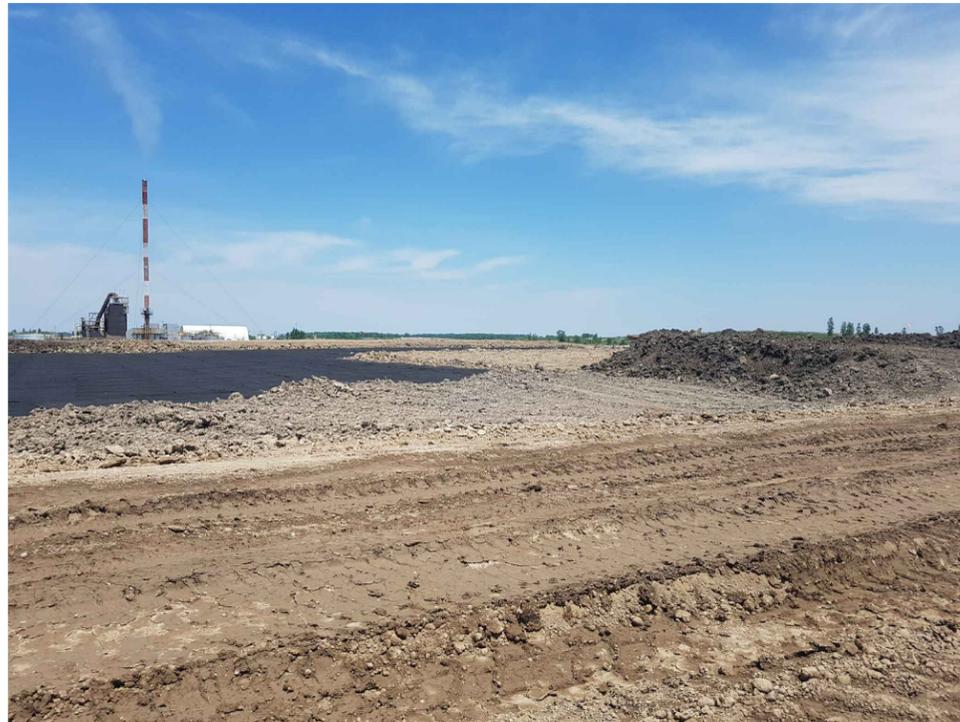
5 FINAL COVER - PROTECTIVE COVER PLACEMENT CELL 19-1
Fig 3A

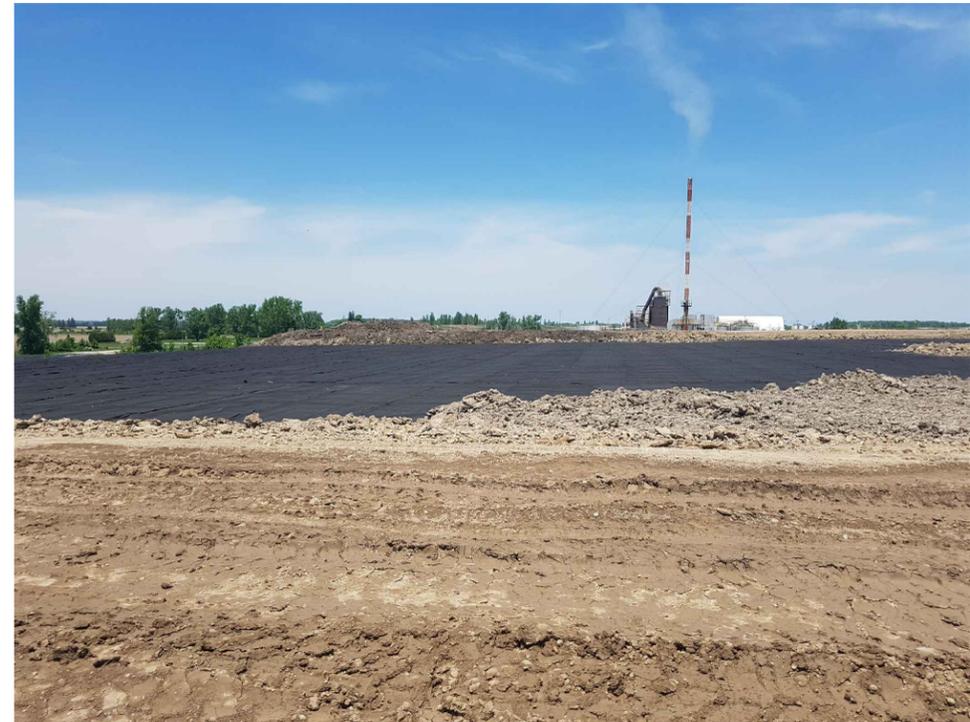
6 FINAL COVER - PROTECTIVE COVER PLACEMENT CELL 19-1
Fig 3A

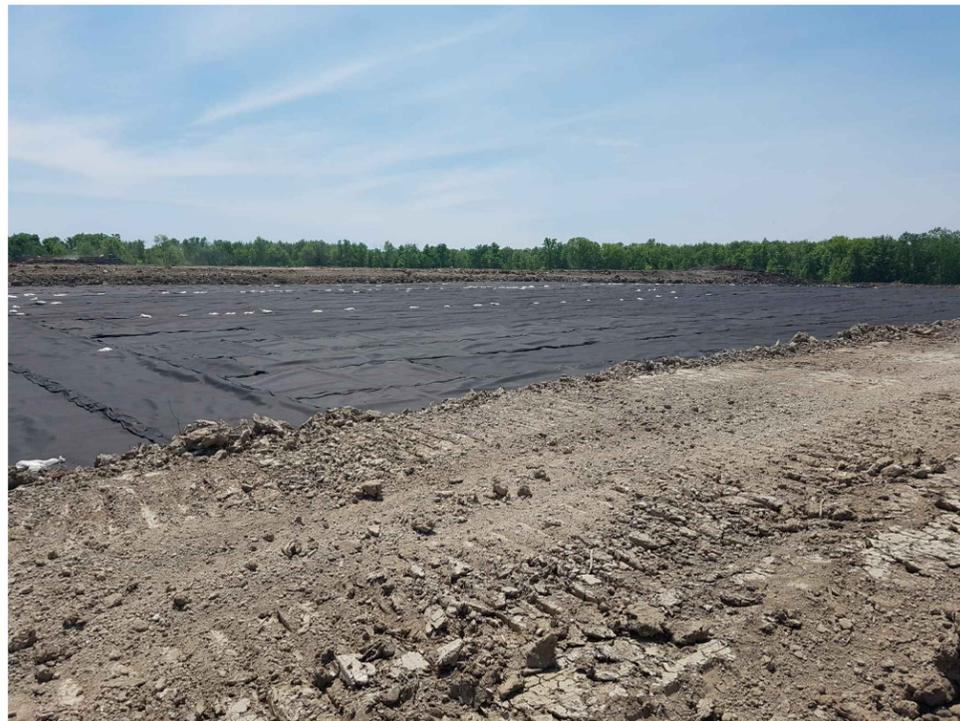
7 FINAL COVER - PROTECTIVE COVER PLACEMENT CELL 19-1
Fig 3A

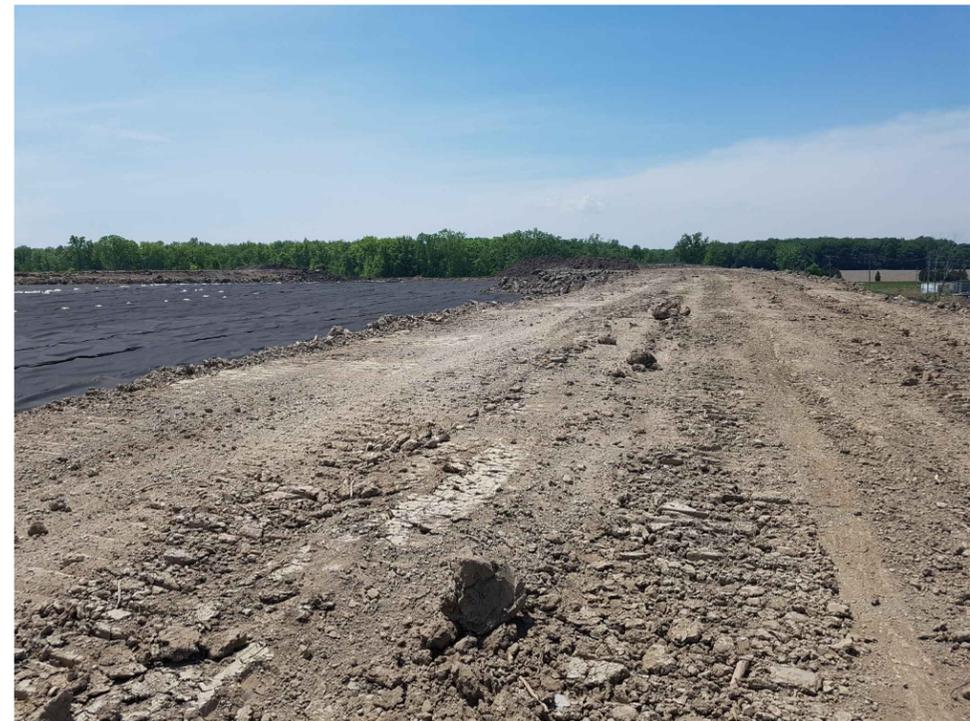
8 FINAL COVER - PROTECTIVE COVER PLACEMENT CELL 19-1
Fig 3A

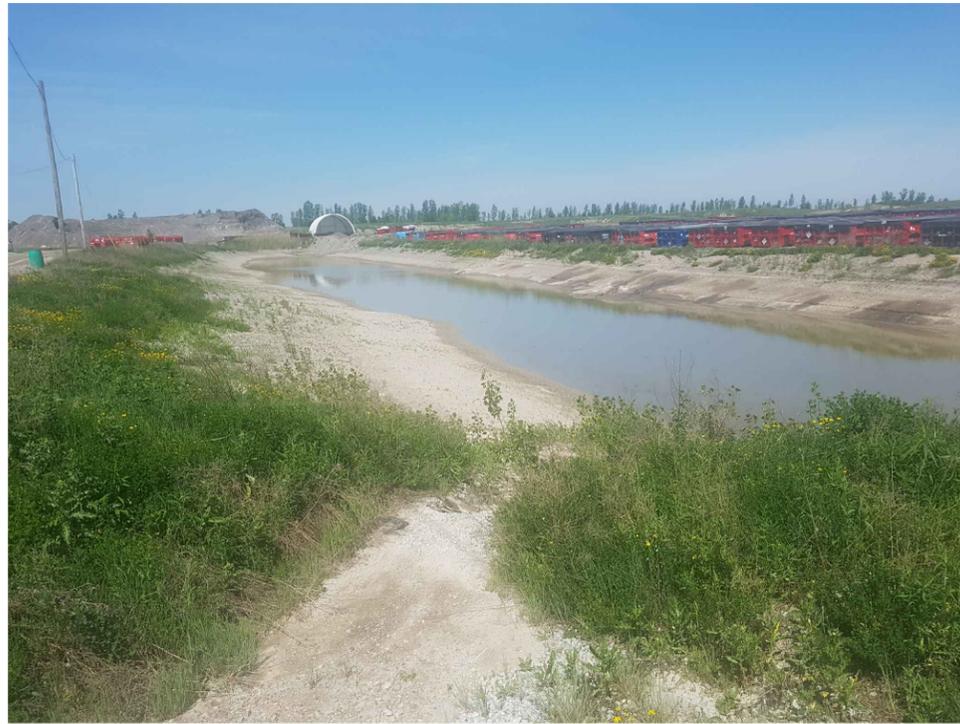
13 EAST PROCESS POND
Fig 4A

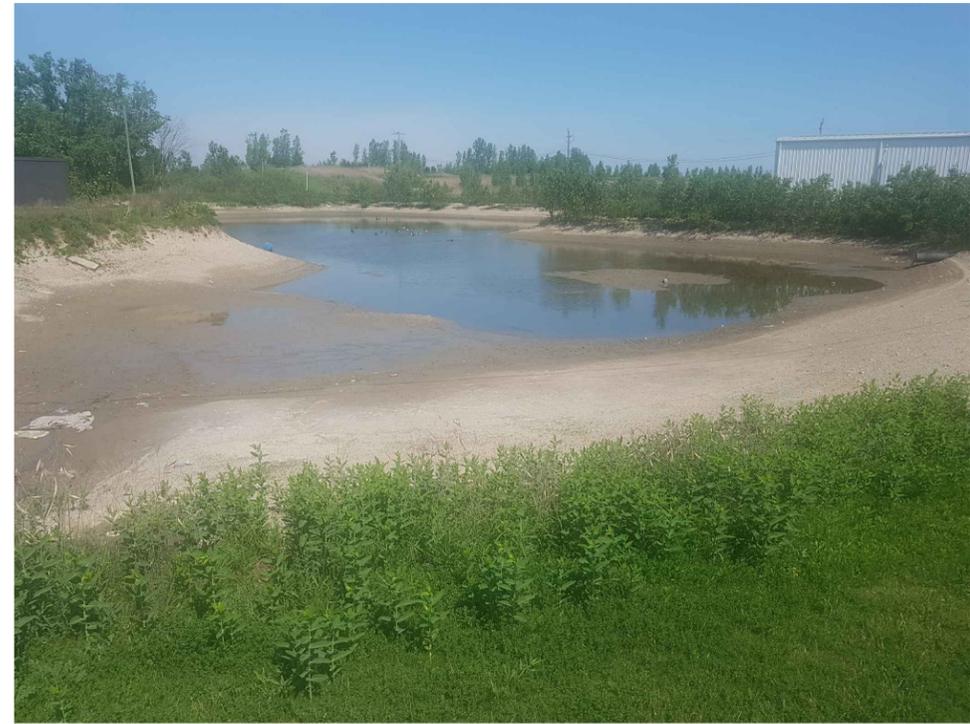
14 NORTH PROCESS POND
Fig 4A

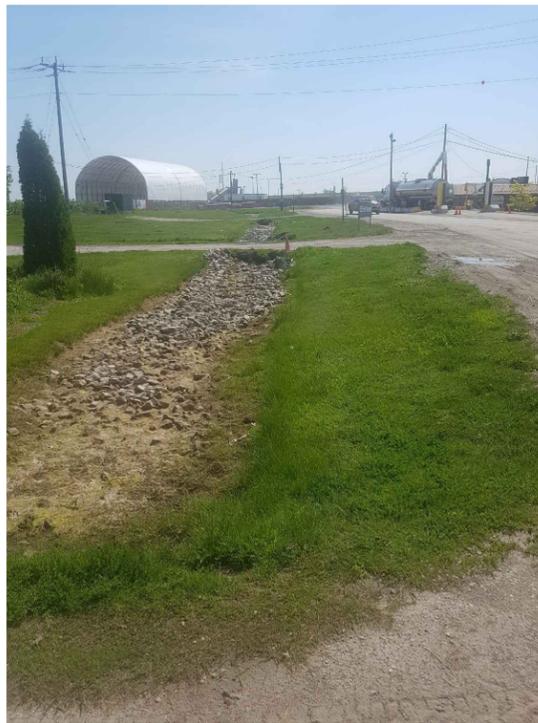
15 PROCESS DITCH
Fig 4A

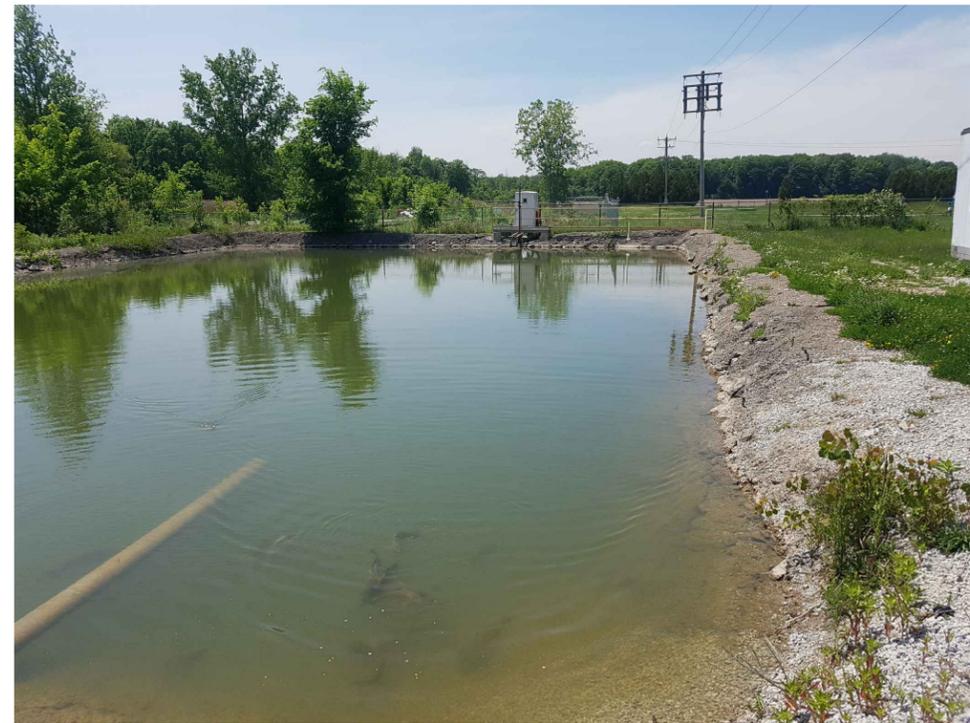
16 EQ POND
Fig 4A

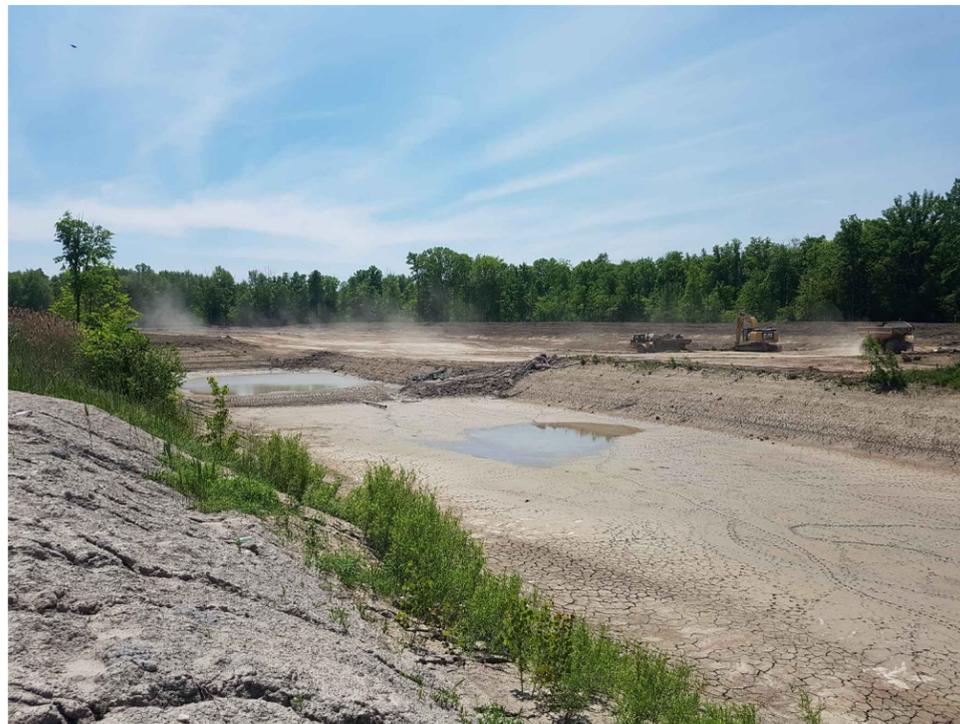
17 WEST SURFACE WATER POND
Fig 4A

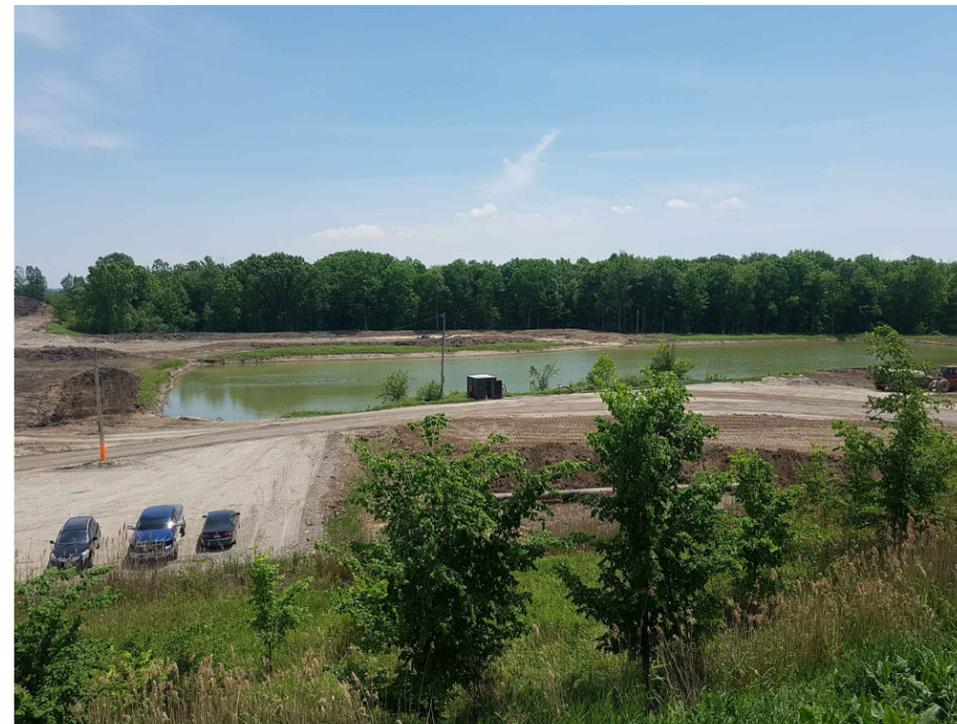
18 EAST SURFACE WATER POND
Fig 4A

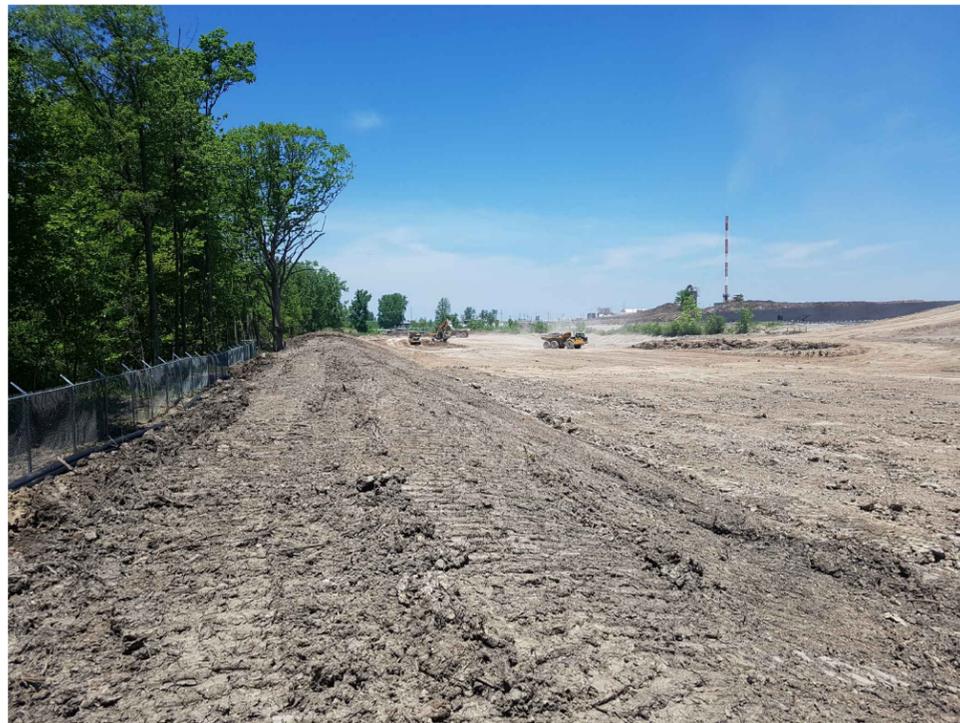
19 2020 CAPITAL WORKS POND C AREA
Fig 4A

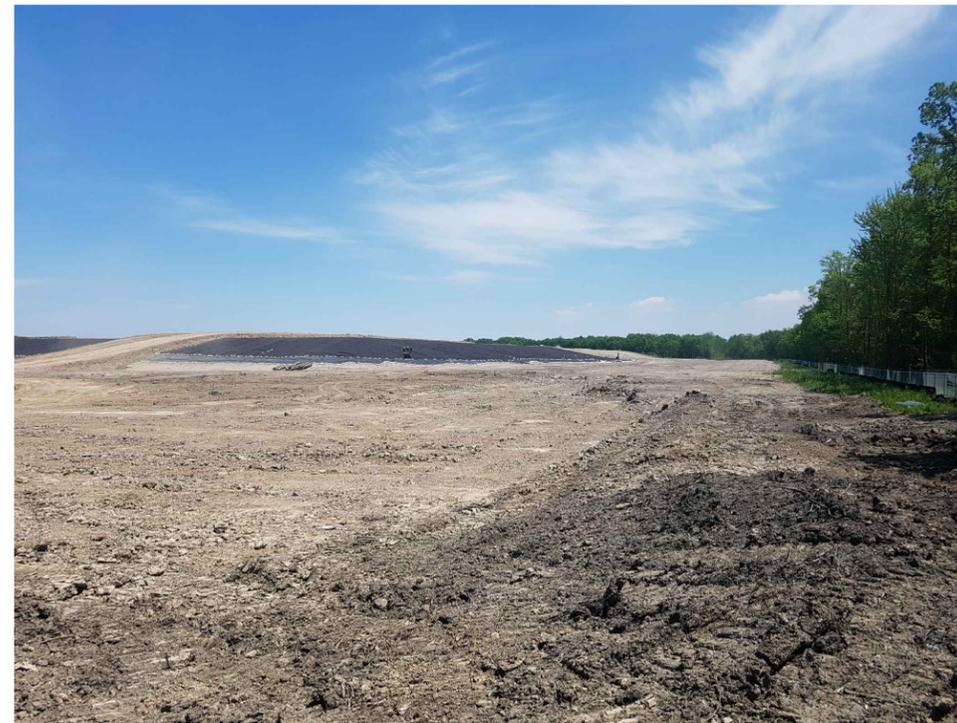
20 2020 CAPITAL WORKS POND C AREA
Fig 4A

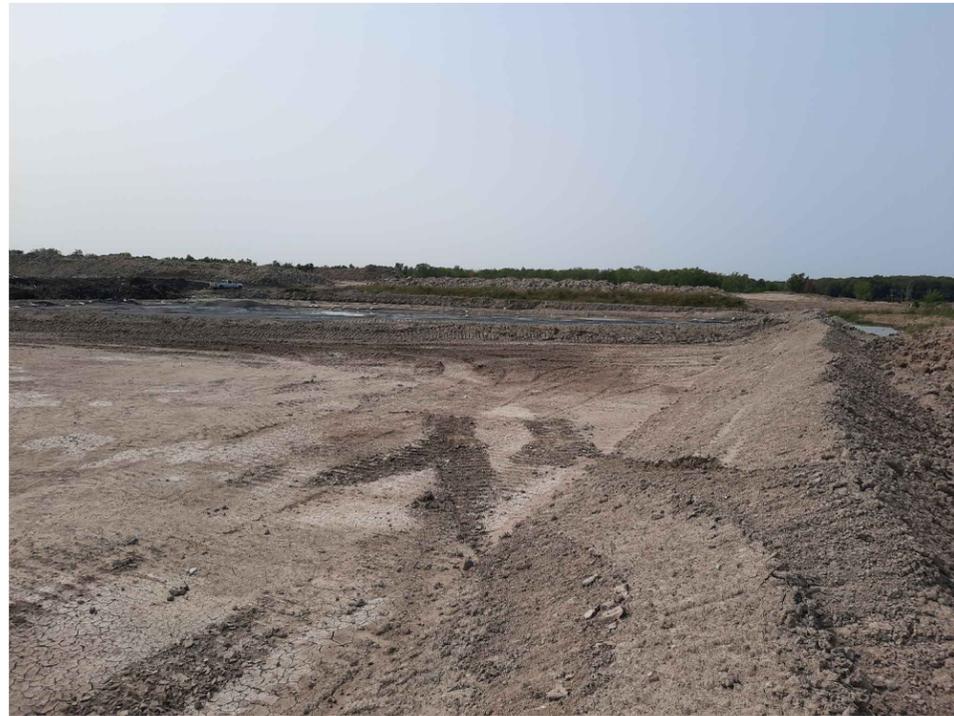
1 CELL 19-3B CONSTRUCTION
Fig 3A

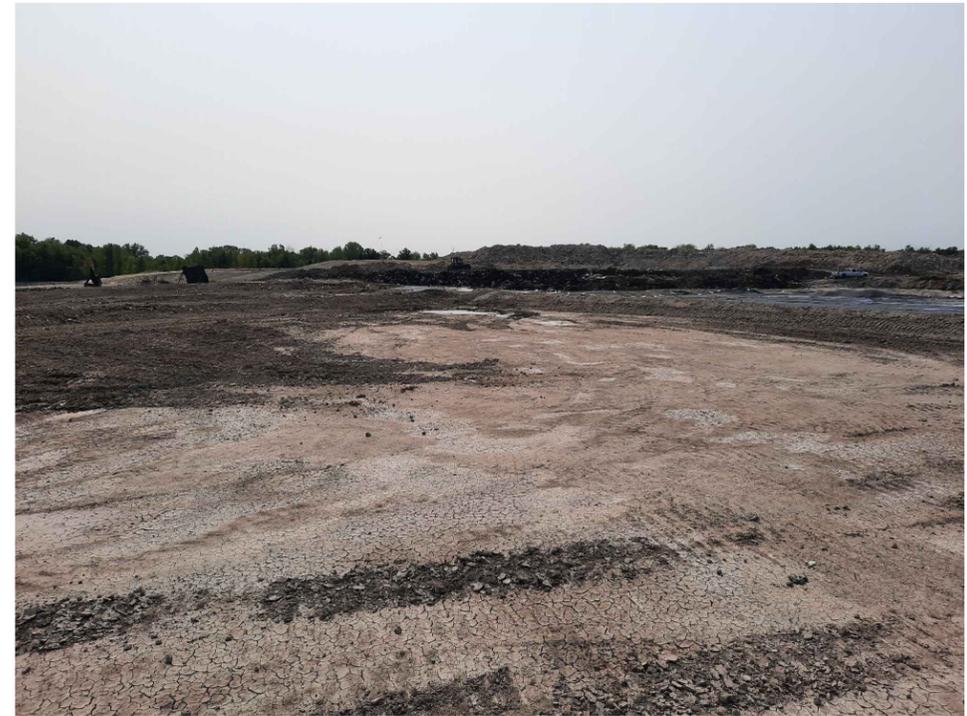
2 CELL 19-3B CONSTRUCTION
Fig 3A

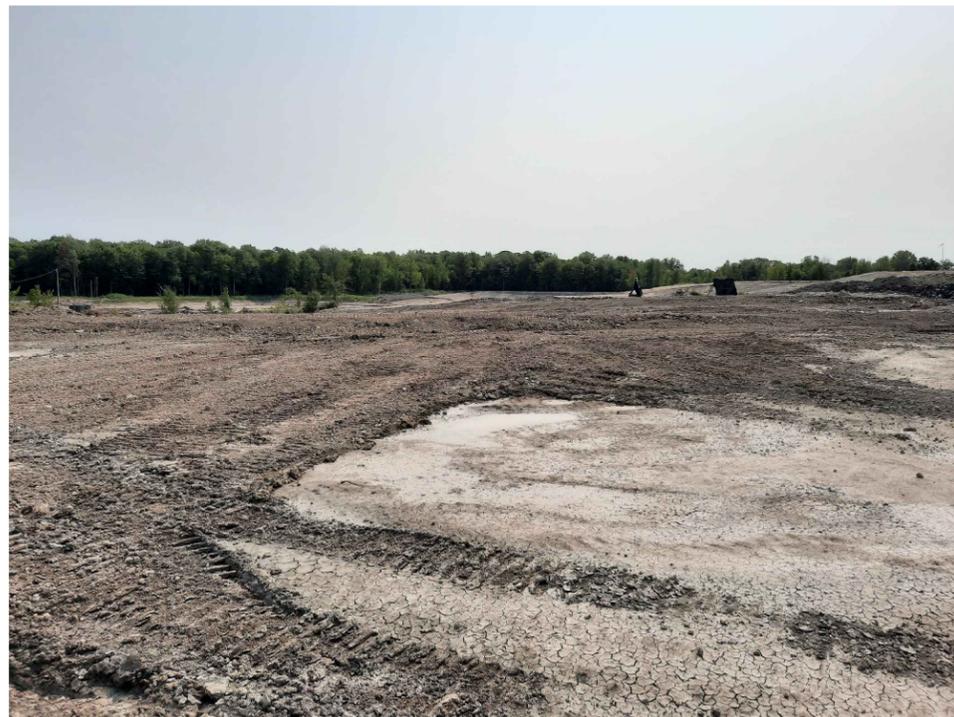
3 CELL 19-3B CONSTRUCTION
Fig 3A

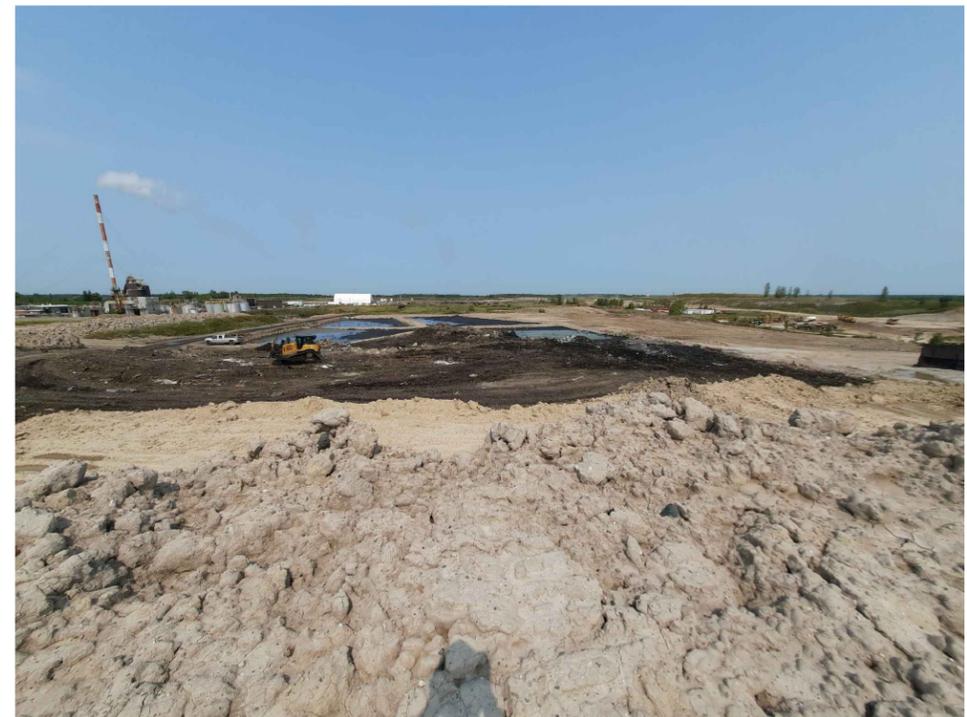
4 CELL 19-2F WASTE FACE
Fig 3A

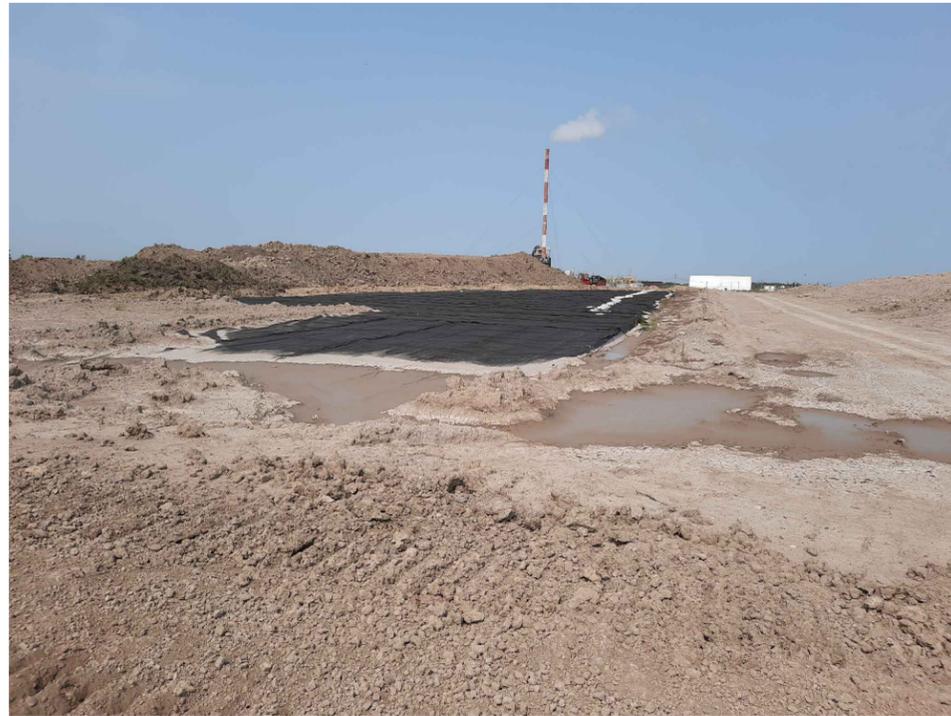
5 FINAL COVER - PROTECTIVE COVER PLACEMENT CELL 19-1
Fig 3A

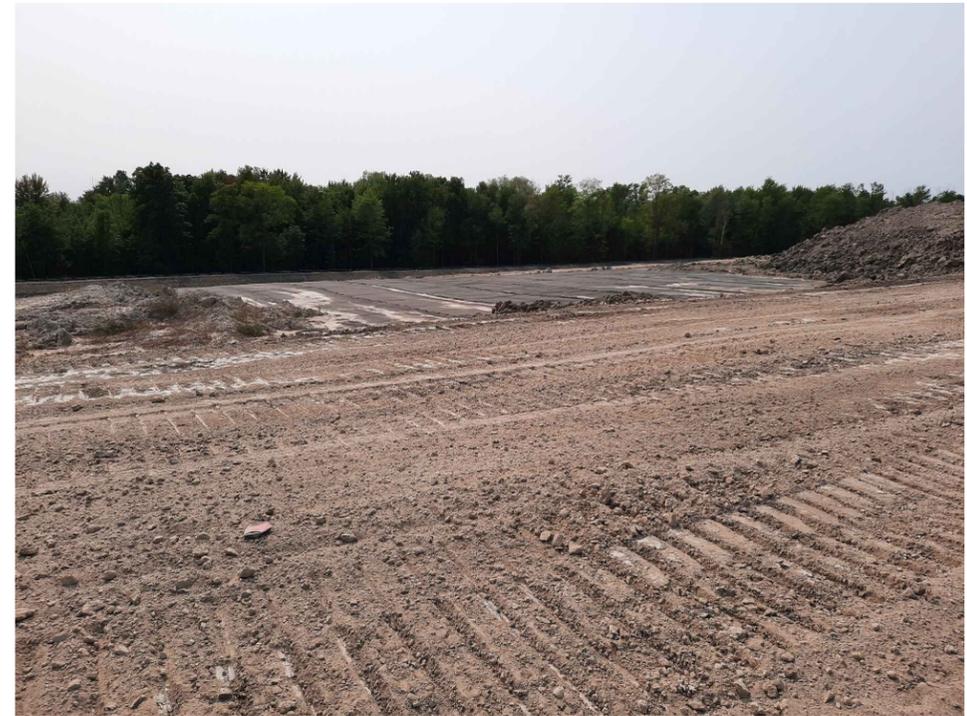
6 FINAL COVER - PROTECTIVE COVER PLACEMENT CELL 19-1
Fig 3A
