2020 Quarterly Site Inspections

Clean Harbors Lambton Facility
4090 Telfer Road, Corunna, Ontario

Clean Harbors Canada, Inc.

Subject: 2020 First Quarter Site Inspection

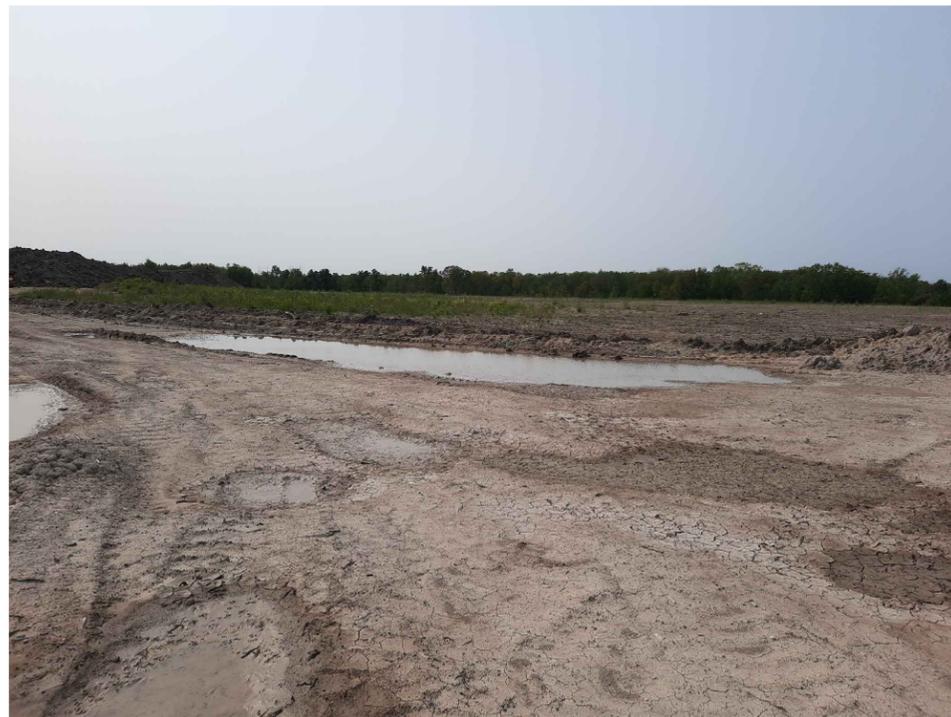
7 FINAL COVER - PROTECTIVE COVER PLACEMENT CELL 19-1
Fig 3A

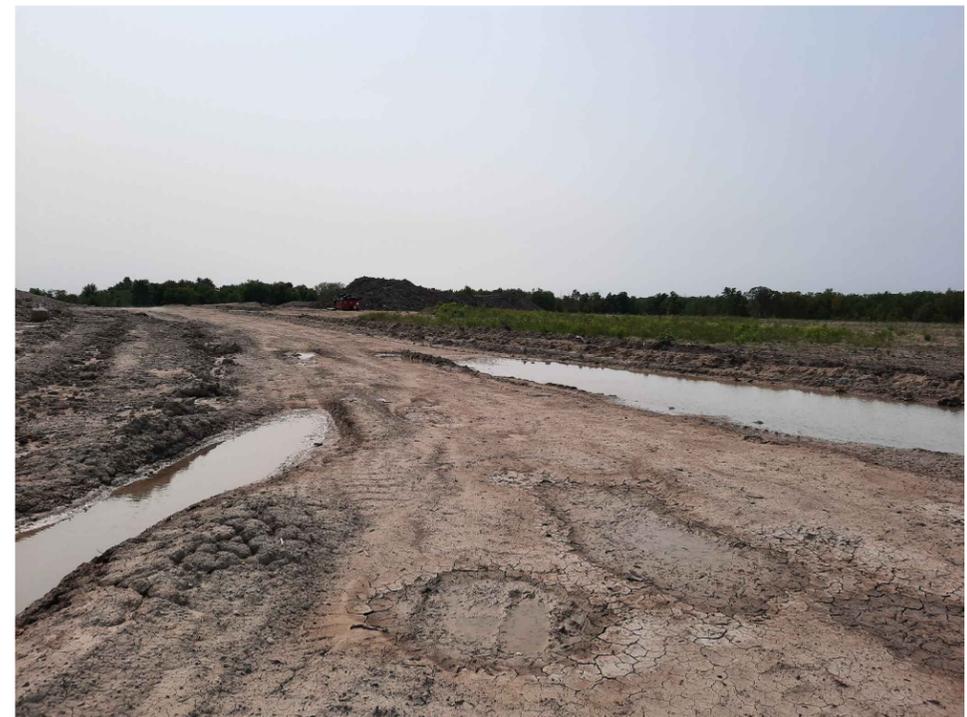
8 FINAL COVER - PROTECTIVE COVER PLACEMENT CELL 19-1
Fig 3A

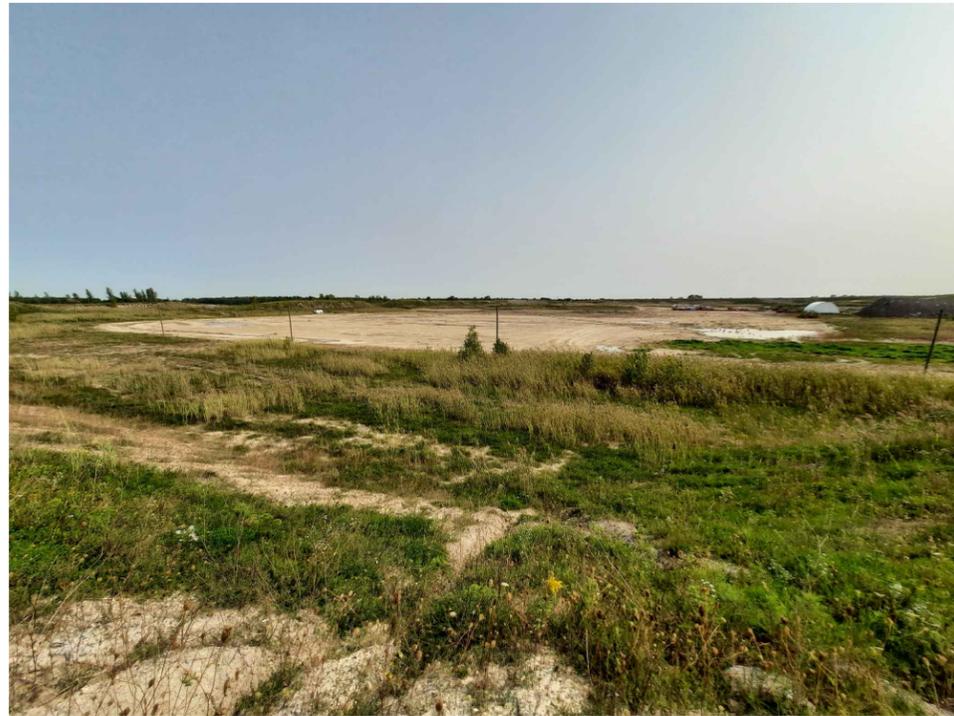
9 REGRADED NORTH AREA
Fig 4A

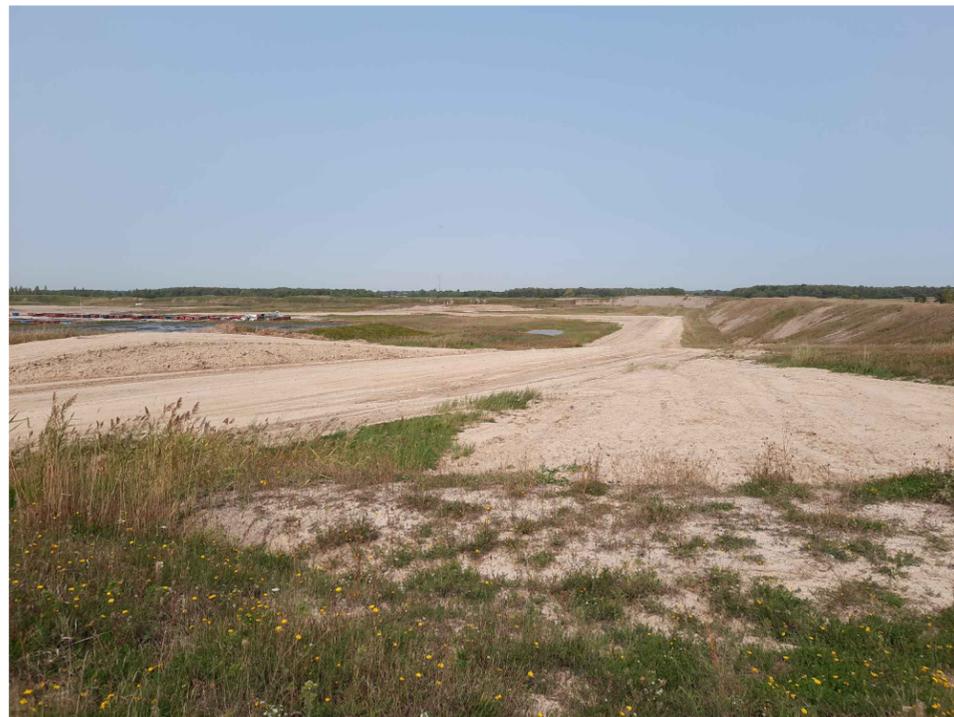
11 NORTH EAST AREA WITH HAUL ROAD
Fig 4A

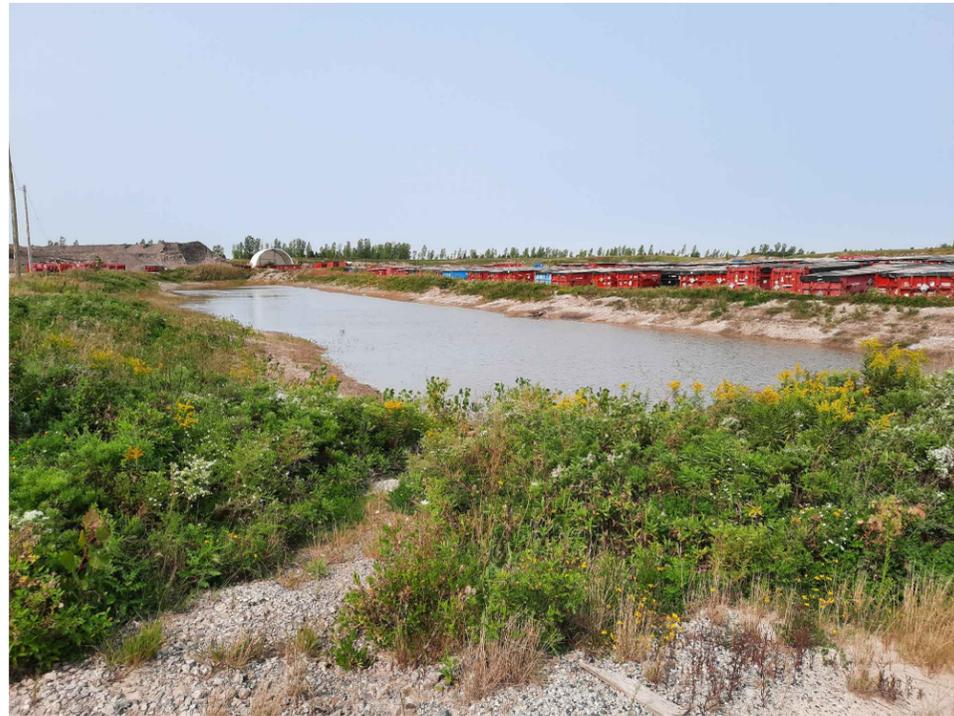
13 EAST PROCESS POND
Fig 4A

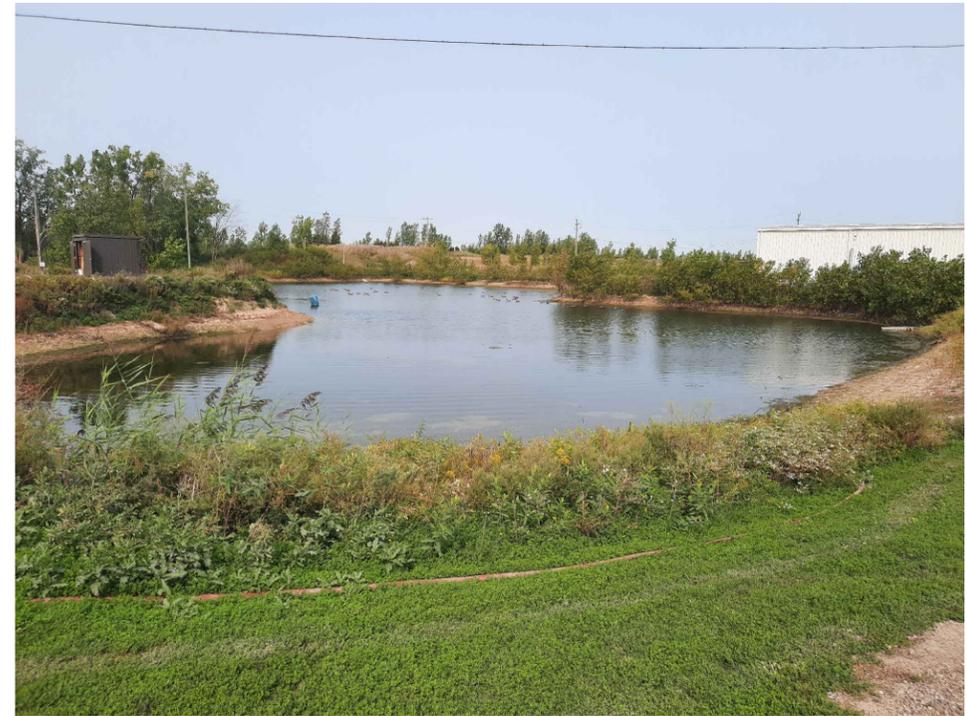
14 NORTH PROCESS POND
Fig 4A

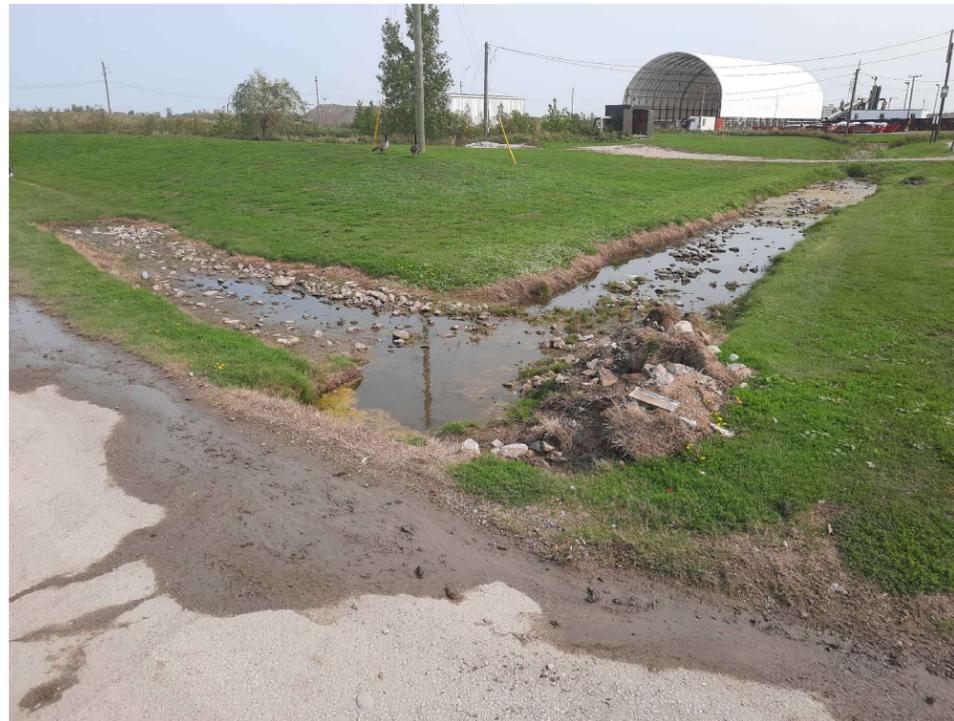
15 PROCESS DITCH
Fig 4A

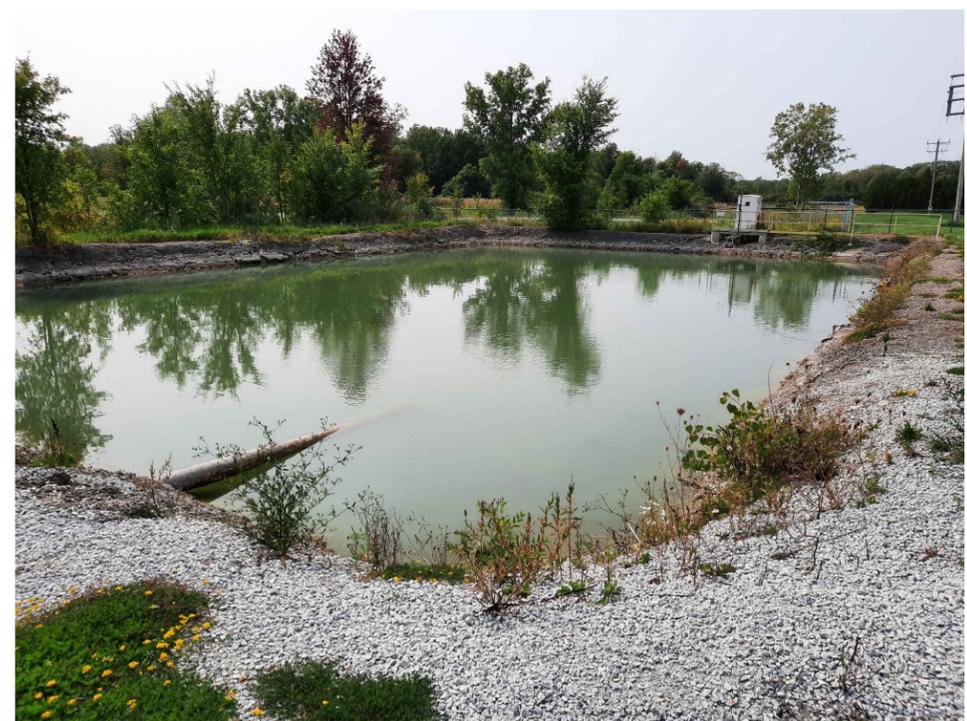
16 EQ POND
Fig 4A

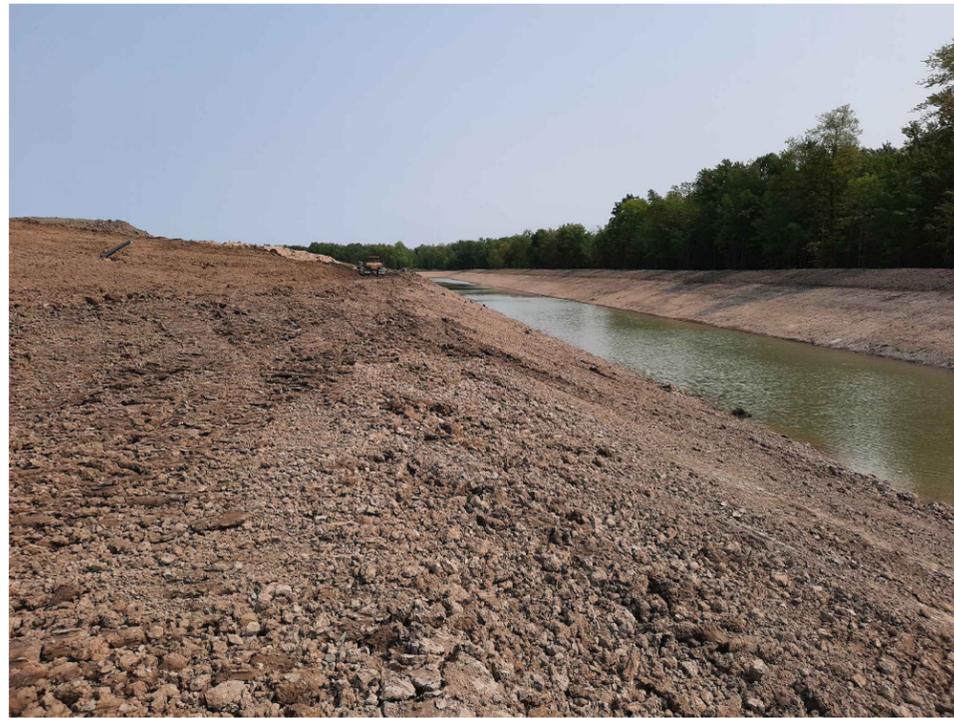
19 SURFACE WATER POND B
Fig 4A

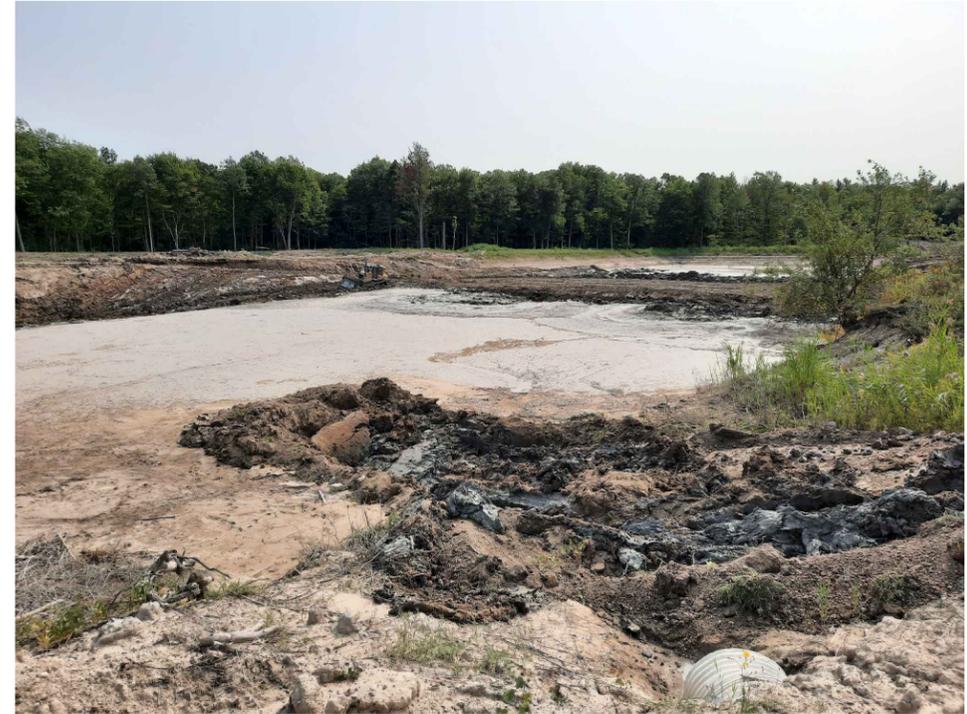
18 EAST SURFACE WATER POND
Fig 4A

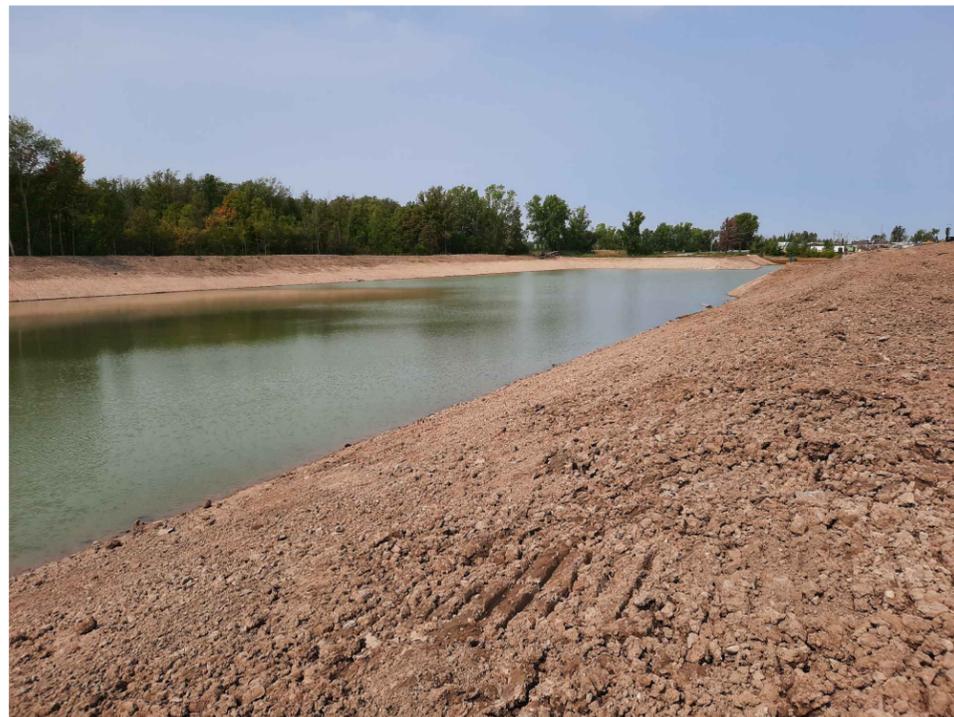
20 SURFACE WATER POND C
Fig 4A

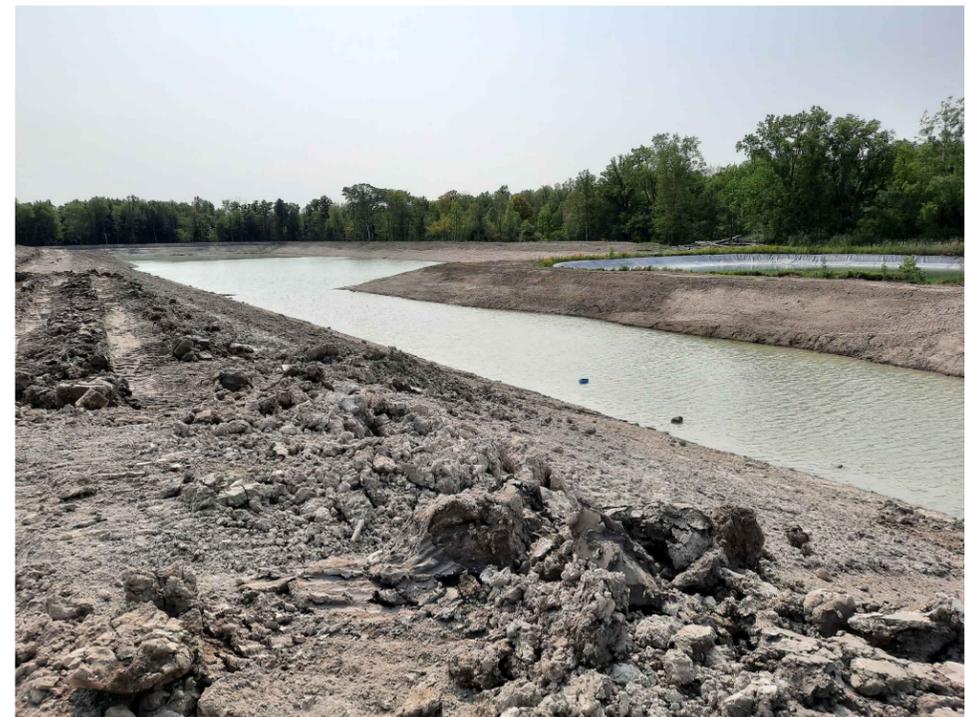
17 SURFACE WATER POND D
Fig 4A

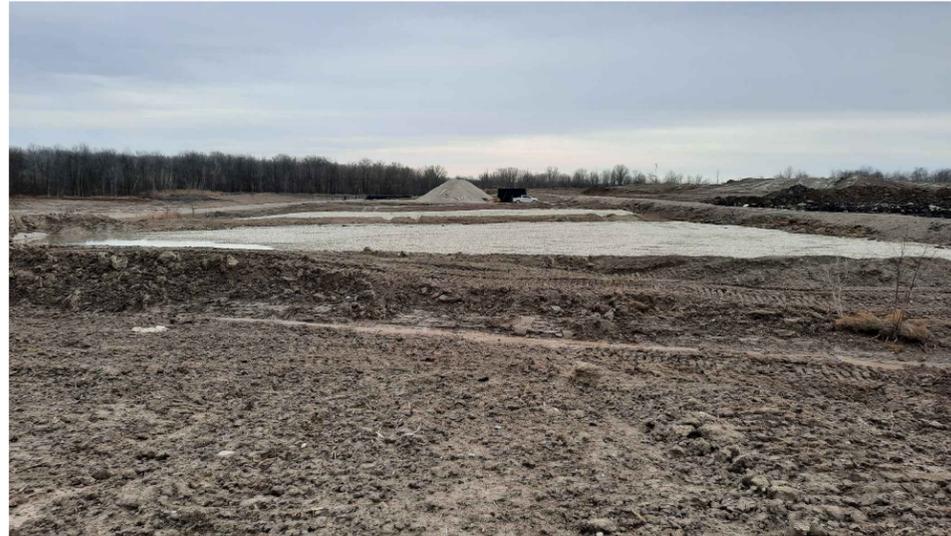
1 CELL 19-3A CONSTRUCTION
Fig 3A

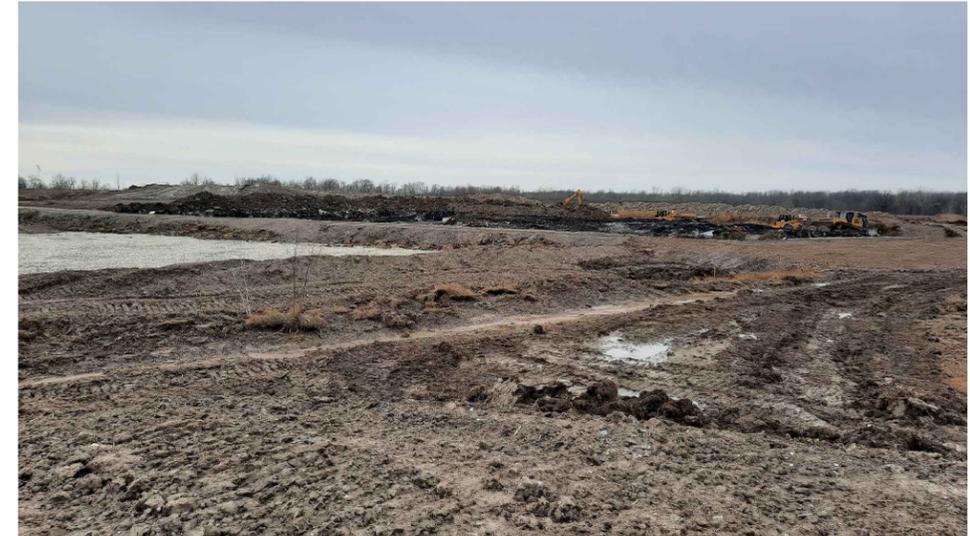
2 CELL 19-3B ACTIVE WASTE FACE
Fig 3A

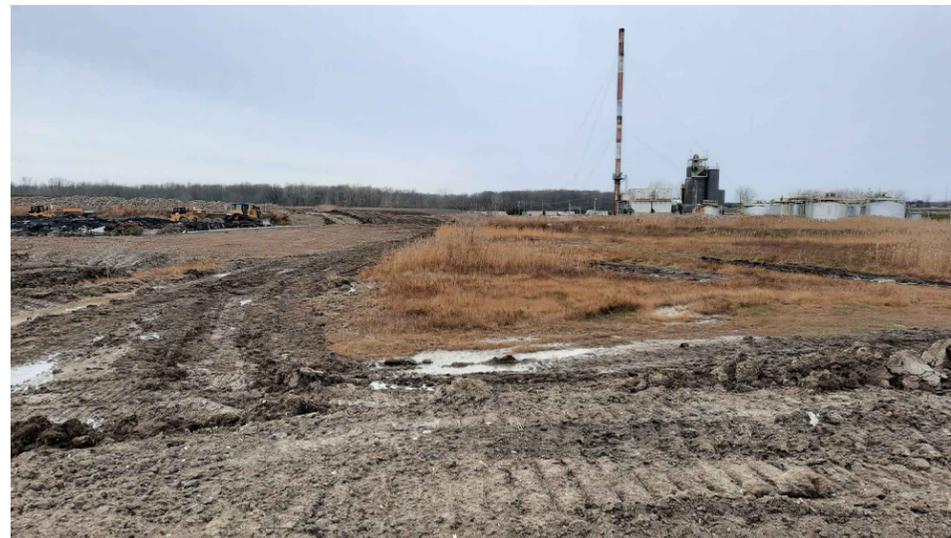
3 CELL 19-3B ACTIVE WASTE FACE
Fig 3A

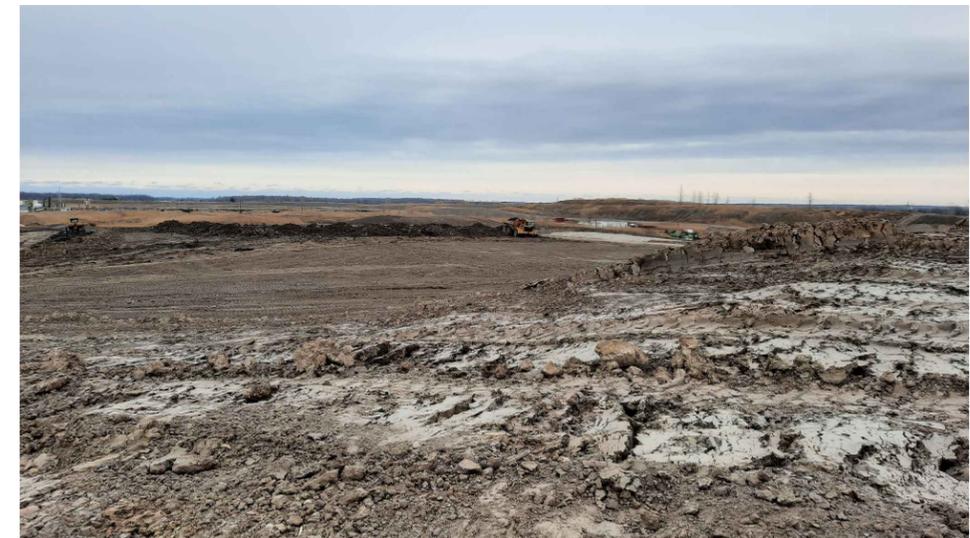
4 CELL 19-3B ACTIVE WASTE FACE
Fig 3A

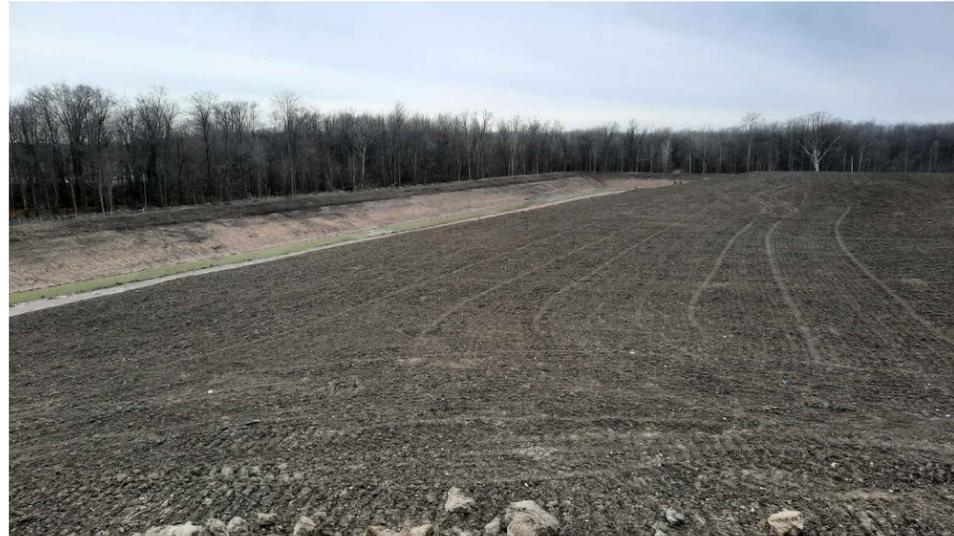
5 FINAL COVER - TOPSOIL PLACEMENT CELL 19-1
Fig 3A

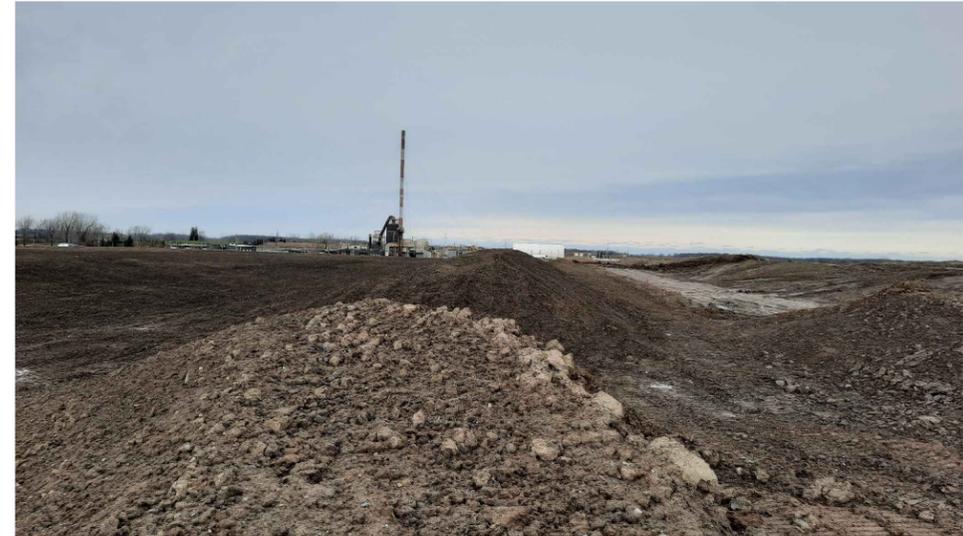
6 FINAL COVER - TOPSOIL PLACEMENT CELL 19-1
Fig 3A

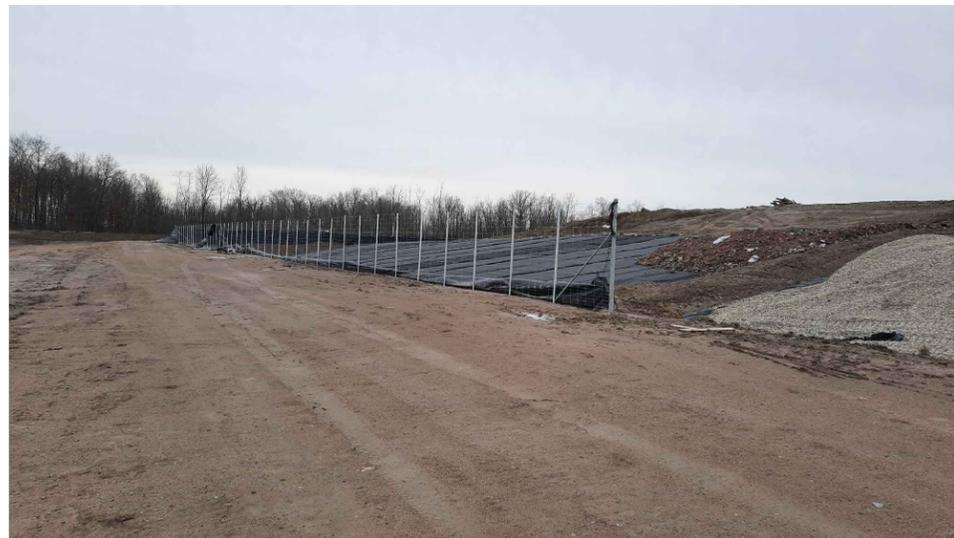
7 CELL 19-2D CONSTRUCTION
Fig 3A

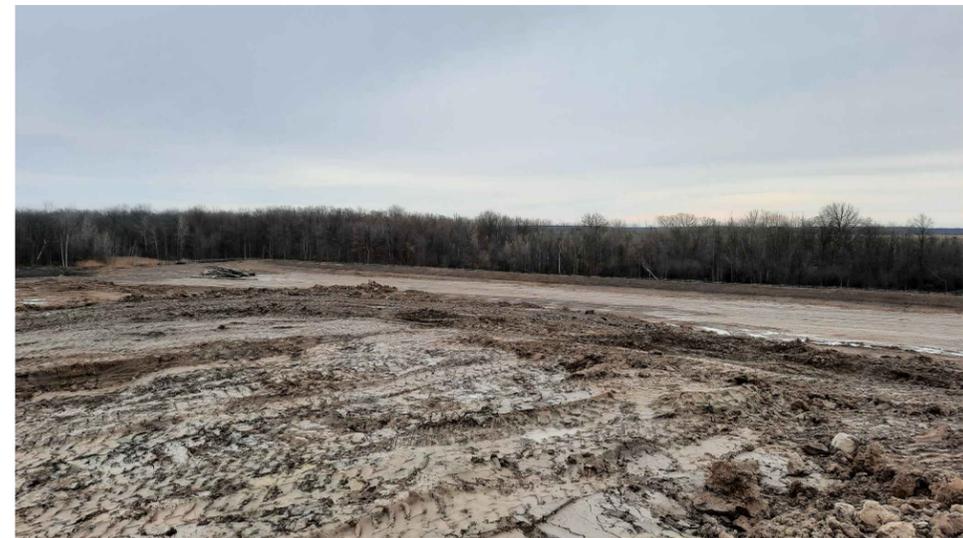
8 CELL 19-2 CLAY STOCKPILE AND INTERIM COVER
Fig 3A

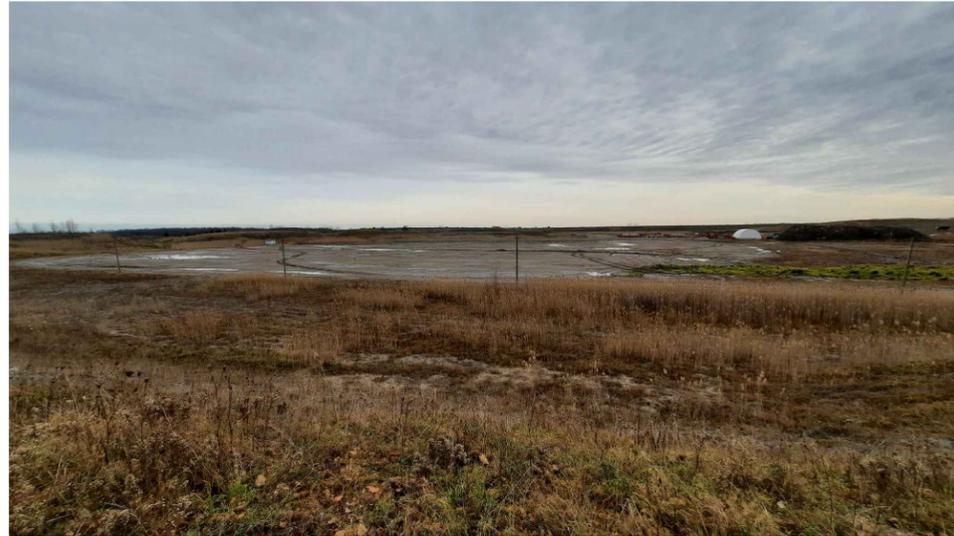
9 REGRADED NORTH AREA
Fig 4A

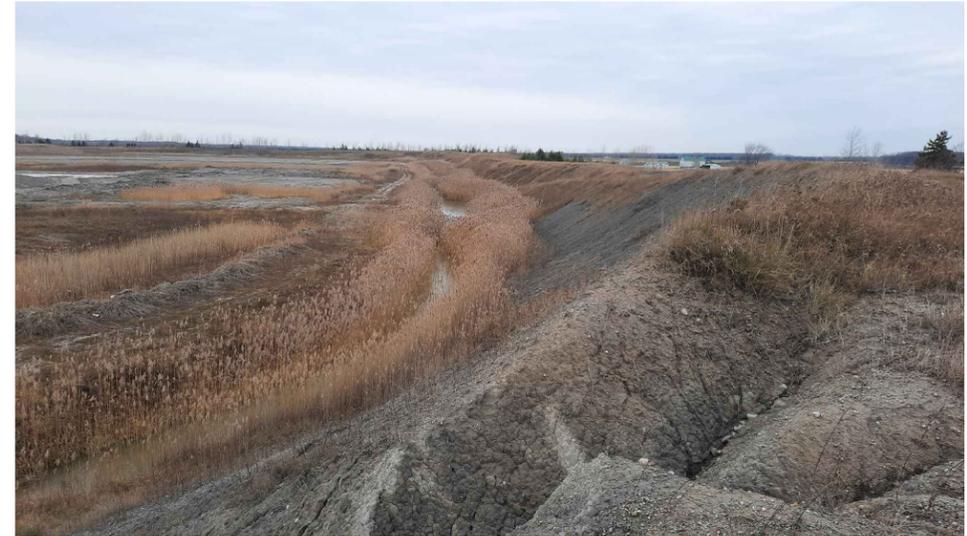
- Several major and minor erosion channels were noted throughout the internal slopes of the perimeter screening berm. These channels have been described and identified on Figure 4A
- Several large erosion channels were noted along the top plateaus of the perimeter screening berm. These channels have been described and identified on Figure 4A.
- Erosion channels are generally in un-vegetated areas.
- Erosion along the internal slopes increases the sedimentation of the perimeter ditches.
- The external sidewalls are in good condition and vegetated.

10 EROSION CHANNELS ALONG NORTH PERIMETER BERM
Fig 4A

- It is recommended that low/depressed areas in the northeast portion of the Site to are assessed and the interim cover regraded to promote drainage.
- As active site works progress from south to north it is recommended that the perimeter berm is regraded, topsoiled, and seeded to prevent future erosion in to the surface water system.
- A preventative maintenance program is recommended for the perimeter ditches and culverts. Preventative maintenance completed in the spring and fall will insure adequate surface water drainage from the north portion of the site. Maintenance includes removing silt, cutting back vegetation and removing blockages.

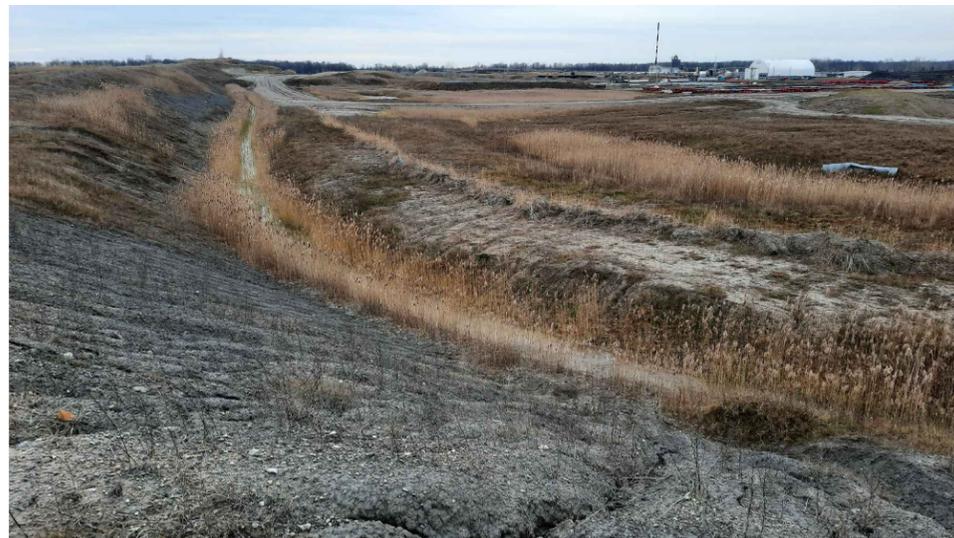
11 EROSION CHANNELS ALONG EAST PERIMETER BERM
Fig 4A

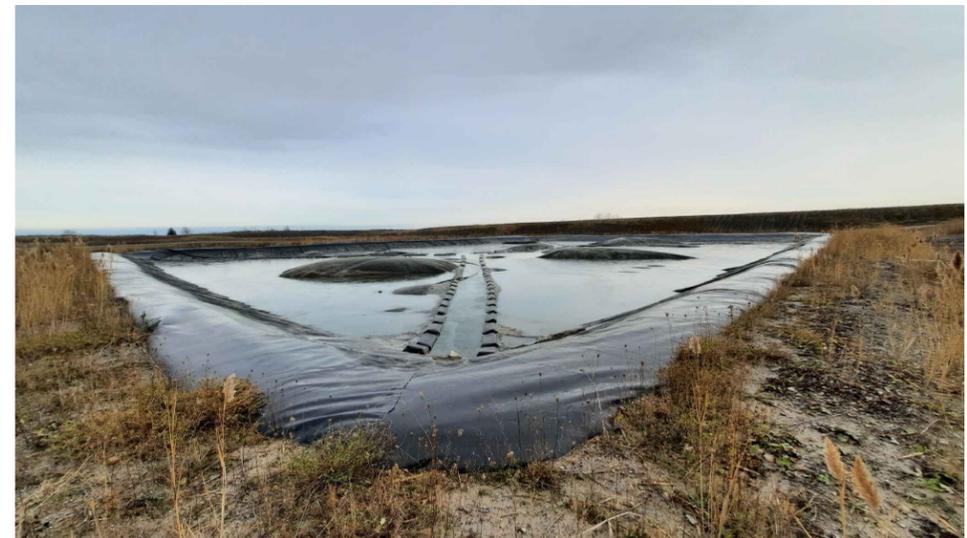
12 PONDED WATER ON EAST LEACHATE POND COVER
Fig 4A

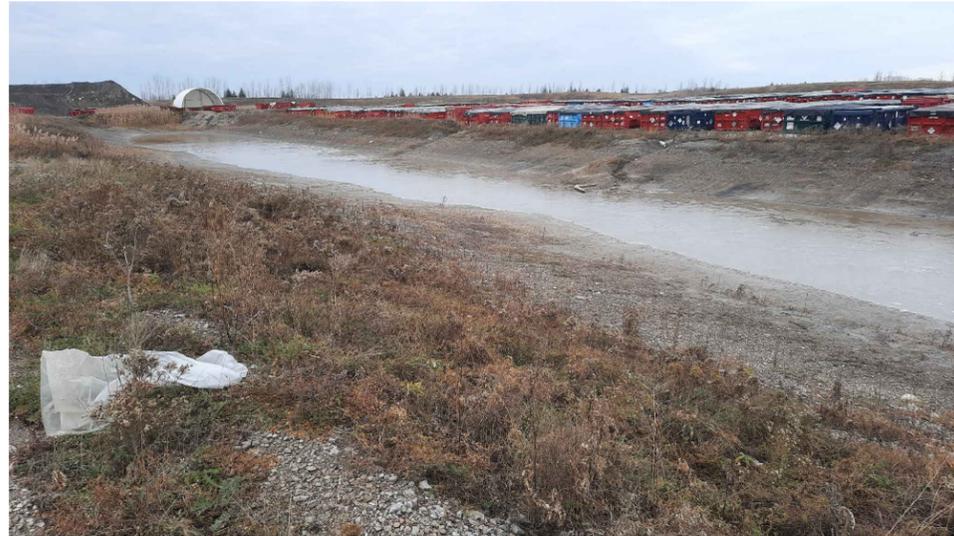
13 EAST PROCESS POND
Fig 4A

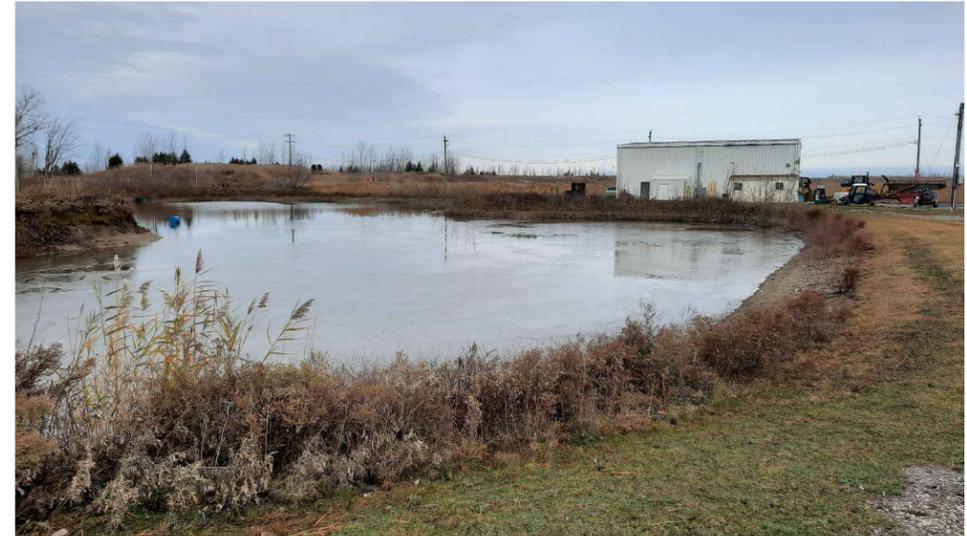
14 NORTH PROCESS POND
Fig 4A

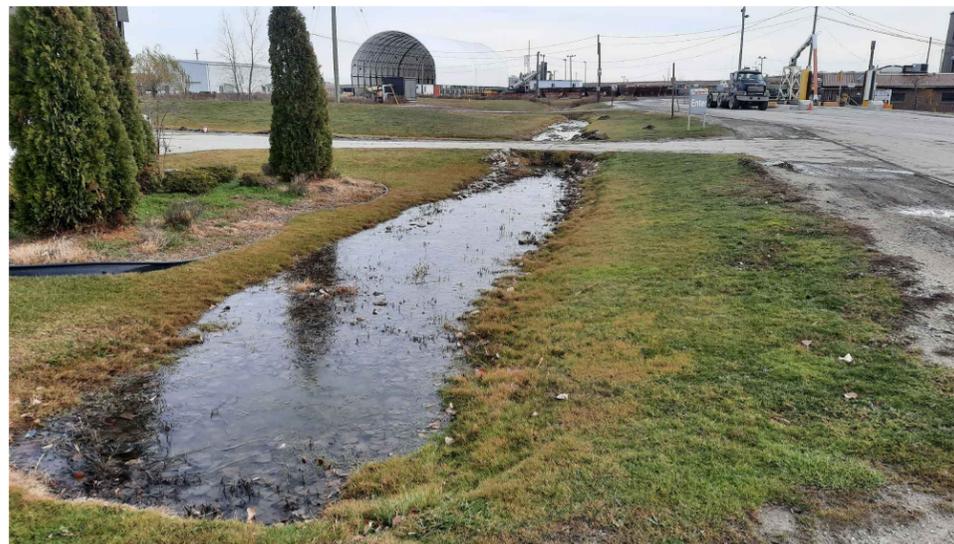
15 PROCESS DITCH
Fig 4A

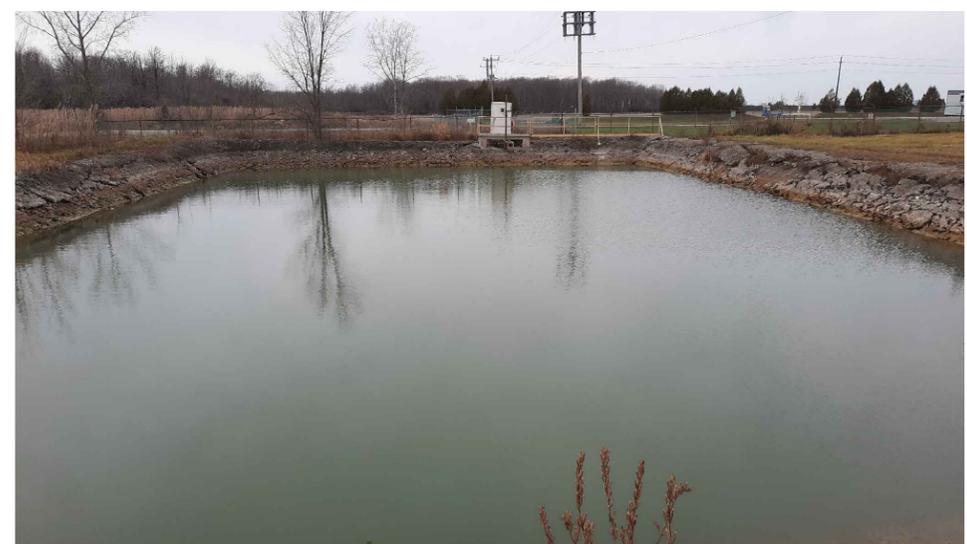
16 EQ POND
Fig 4A

- Figure 4A provides the location and status of the Equalization Pond.
- Fish were not observed within the Equalization Pond.
